## Test report

# Linear joint seals

File           PGA10373a  
Serial No.: 14344  
Ref.:       CAN/TDJ  
Pages:       7  
Encl.:       30

DS/EN 1366-4:2006+A1:2010 Fire resistance tests for service installations- Part 4: Linear joint seals, Annex A Standard condition for linear joint seals with no mechanically induced movement of the joint faces.

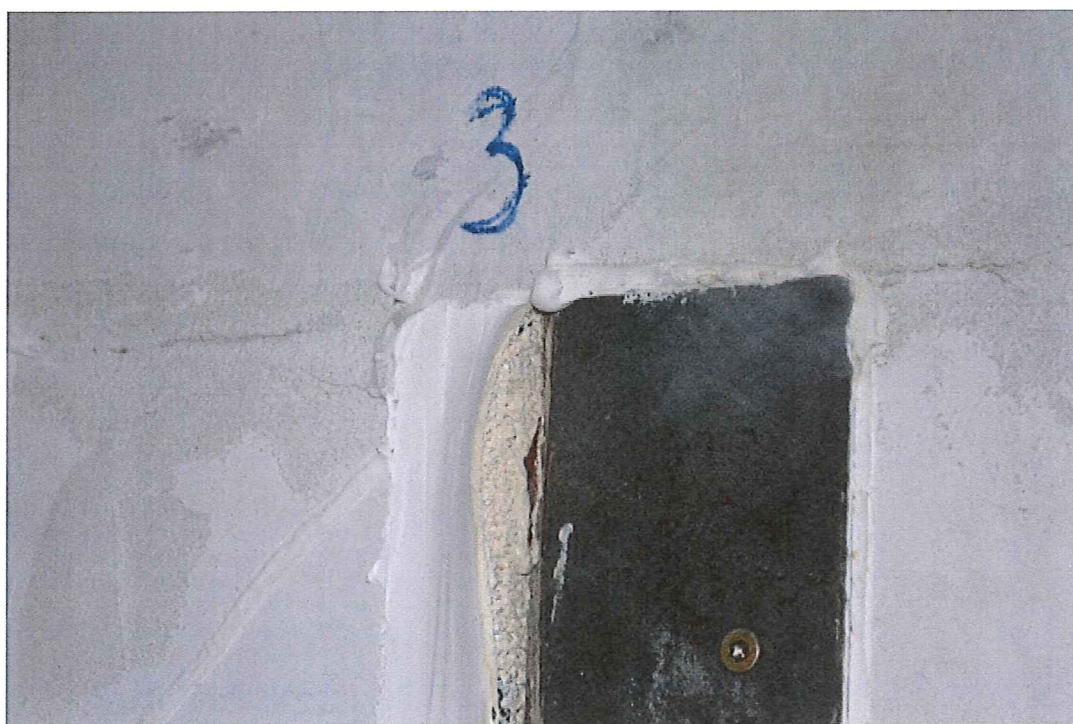
| Time minutes | Test specimen | Observations |
|---|---|---|
| 57 | 3 | Failure of integrity, due to trough going opening in the top of the sealant. |

Photo No. 6 Integrity failure at the top of joint seal 3 after 57 minutes of testing

| Time minutes | Test specimen | Observations |
|---|---|---|
| 58 | 3 | Hole is stopped with ceramic wool. |

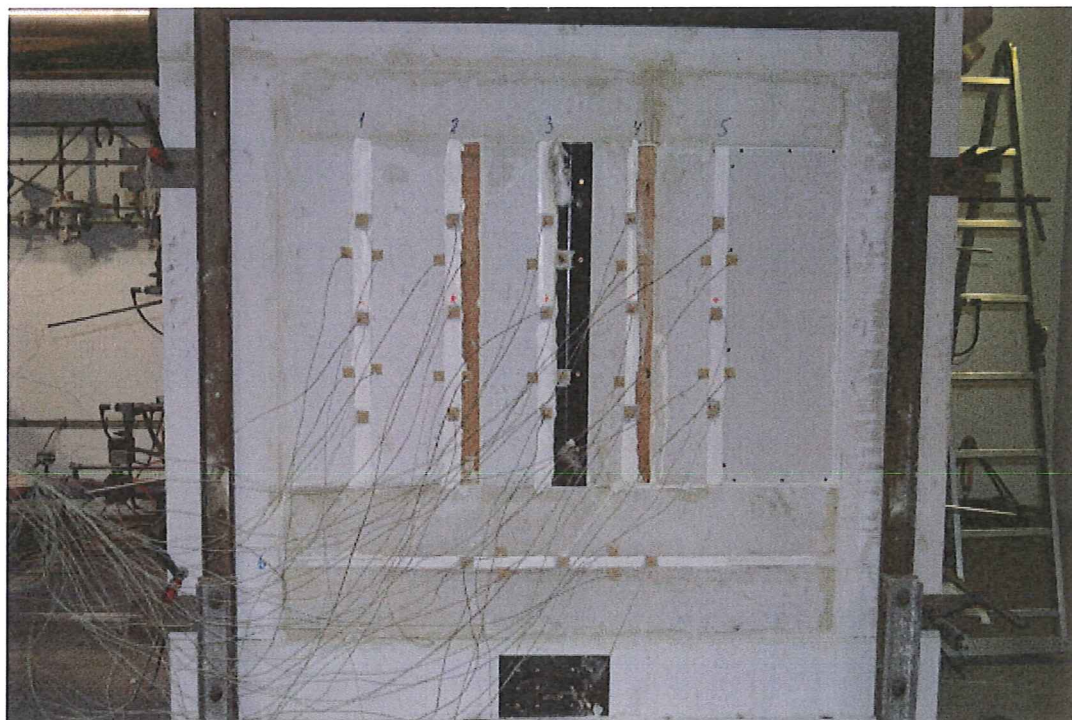
Photo No. 7 Unexposed side of test specimen after 60 minutes of testing

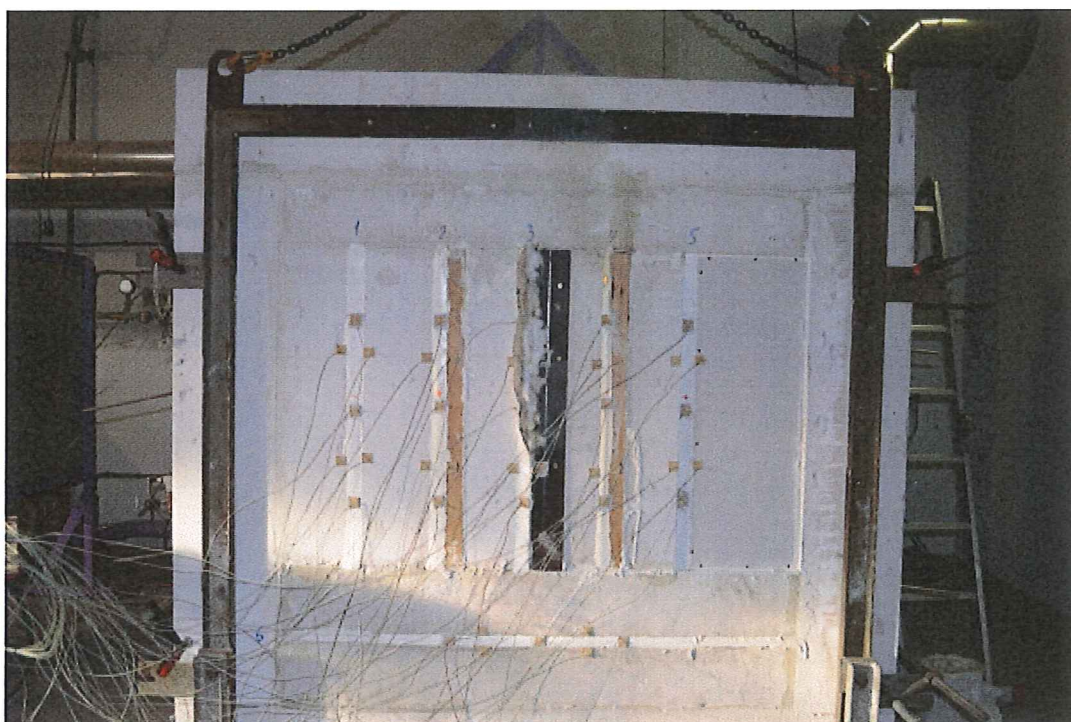
Photo No. 8 Unexposed side of test specimen after 90 minutes of testing

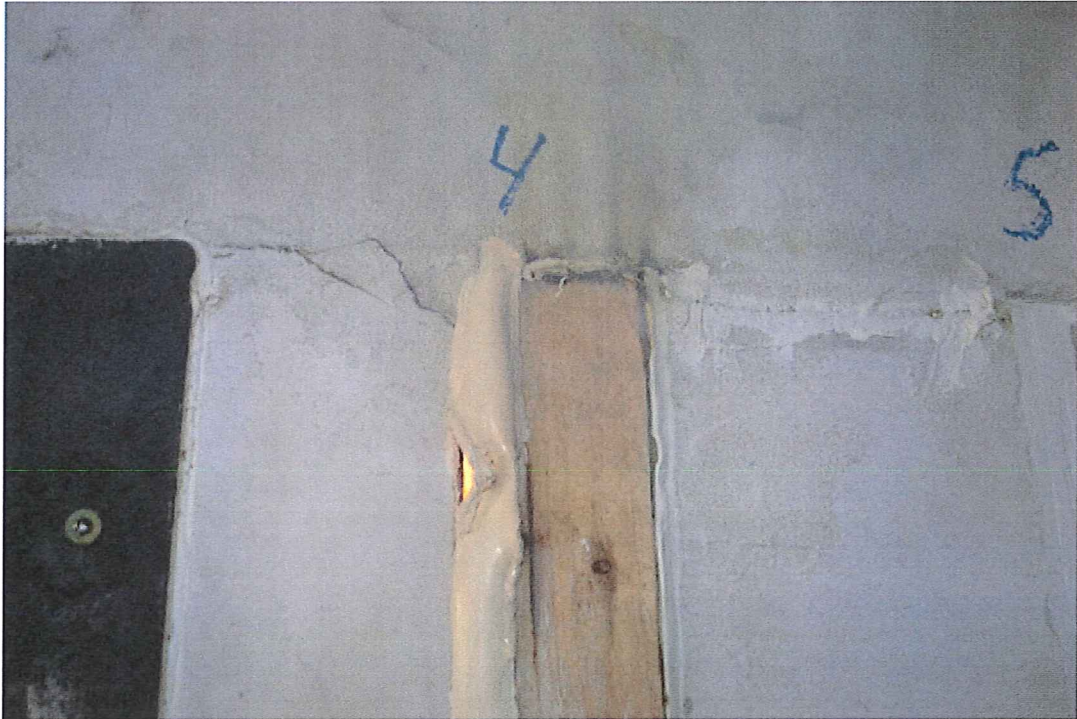
| 90 | 4 | Failure of integrity, due to trough going opening in the top of the sealant. Hole is stopped with ceramic wool. |

Photo No. 9 Integrity failure at the top of joint seal 4 after 90 minutes of testing

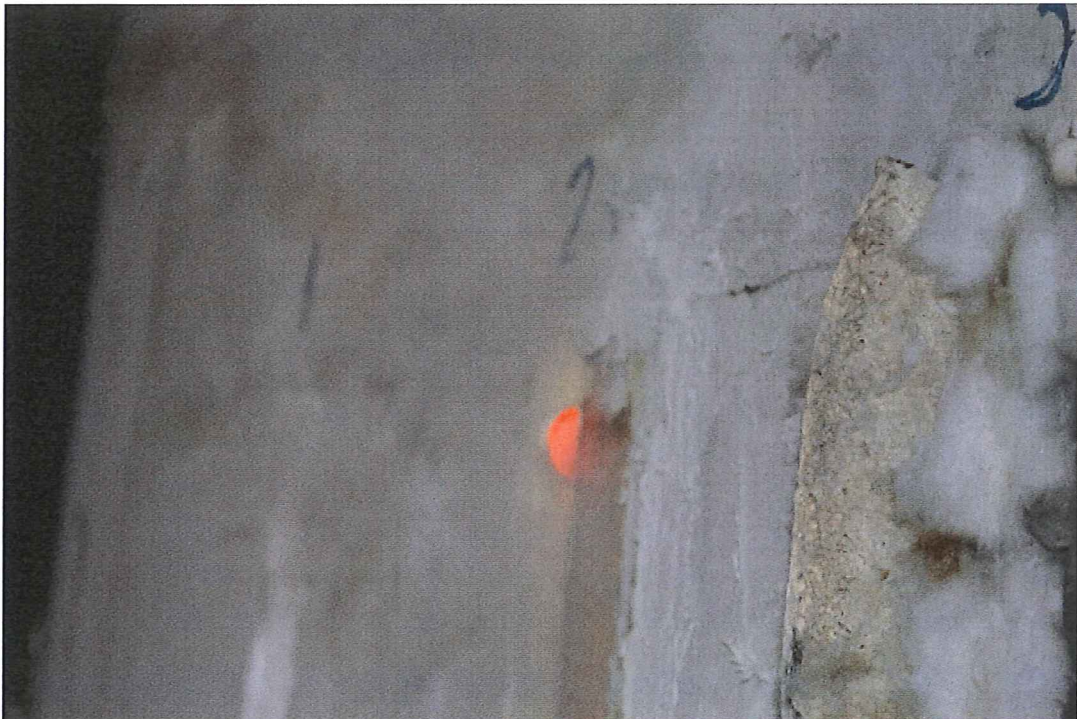
| 96 | 2 | Failure of integrity, due to trough going opening in the top of the sealant. Hole is stopped with ceramic wool. |

Photo No. 10 Integrity failure at the top of joint seal 2 after 96 minutes of testing

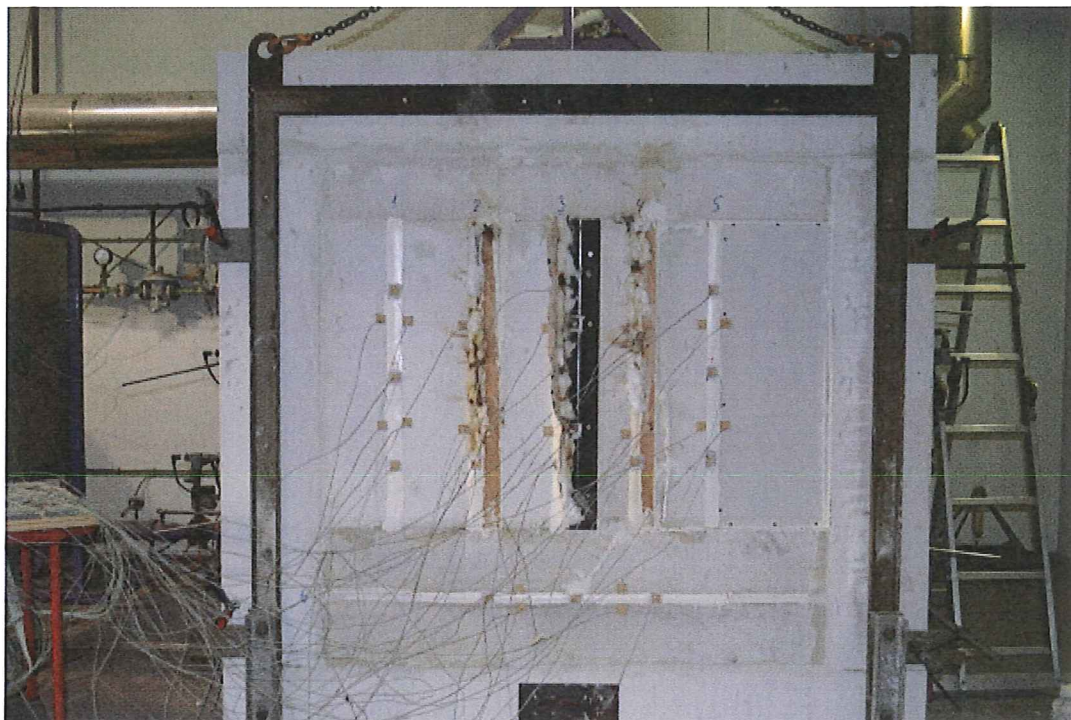
Photo No. 11 Unexposed side of test specimen after 120 minutes of testing

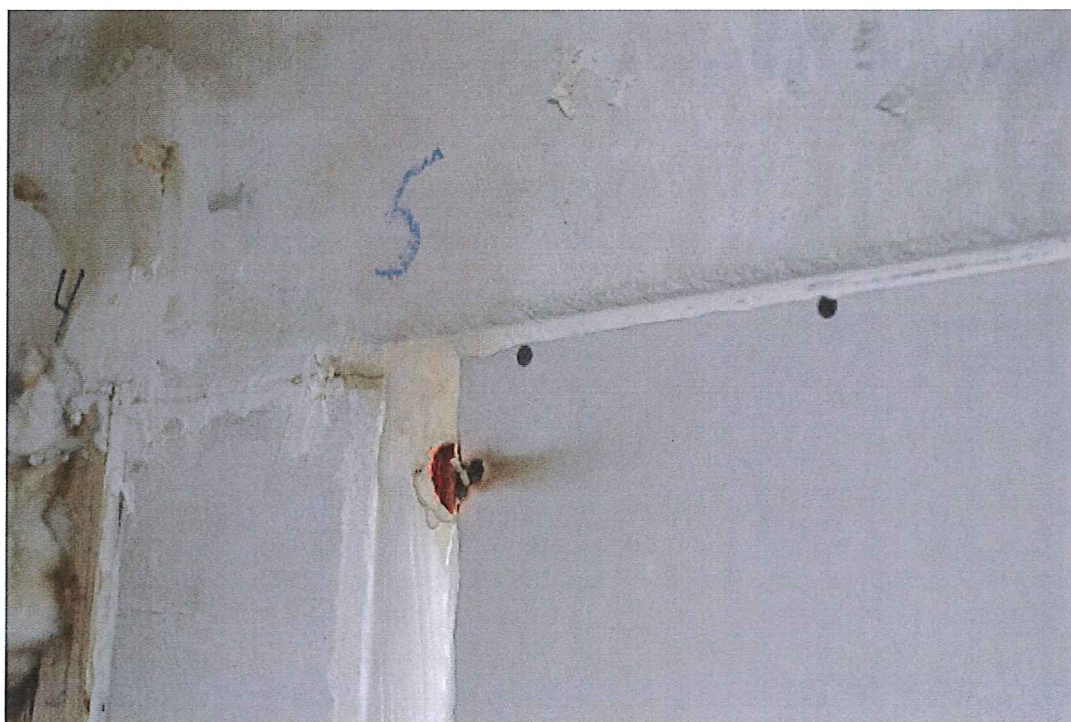
| 123 | 5 | Failure of integrity, due to trough going opening in the top of the sealant. Hole is stopped with ceramic wool. |

Photo No. 12 Integrity failure at the top of joint seal 5 after 123 minutes of testing

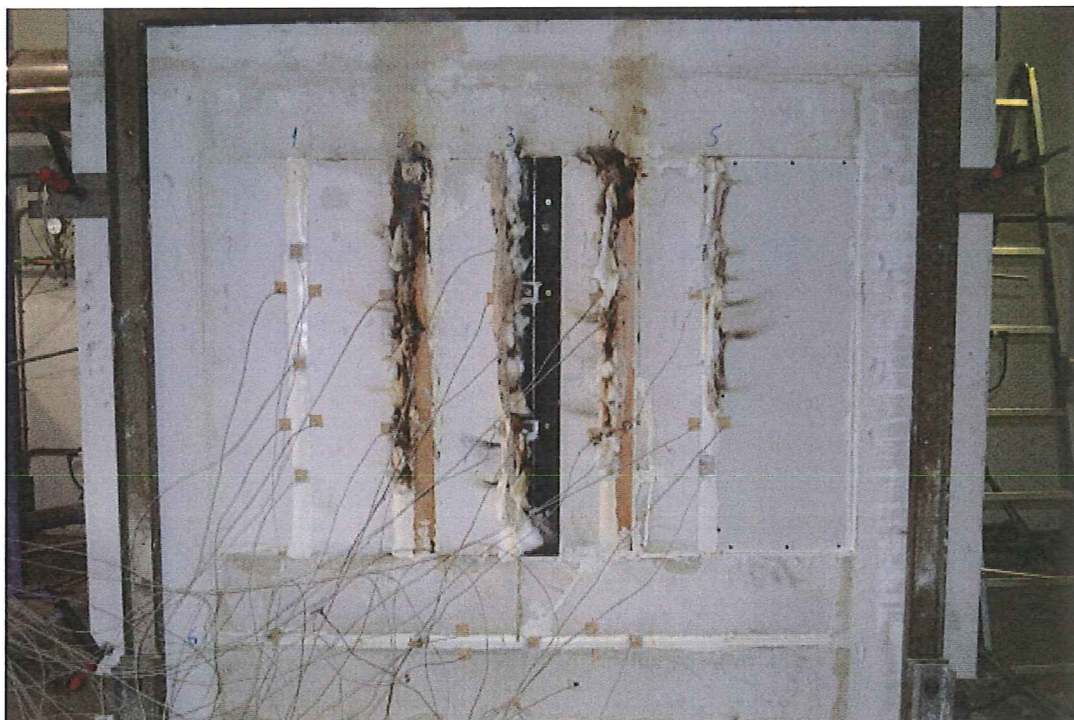
Photo No. 13 Unexposed side of test specimen after 150 minutes of testing

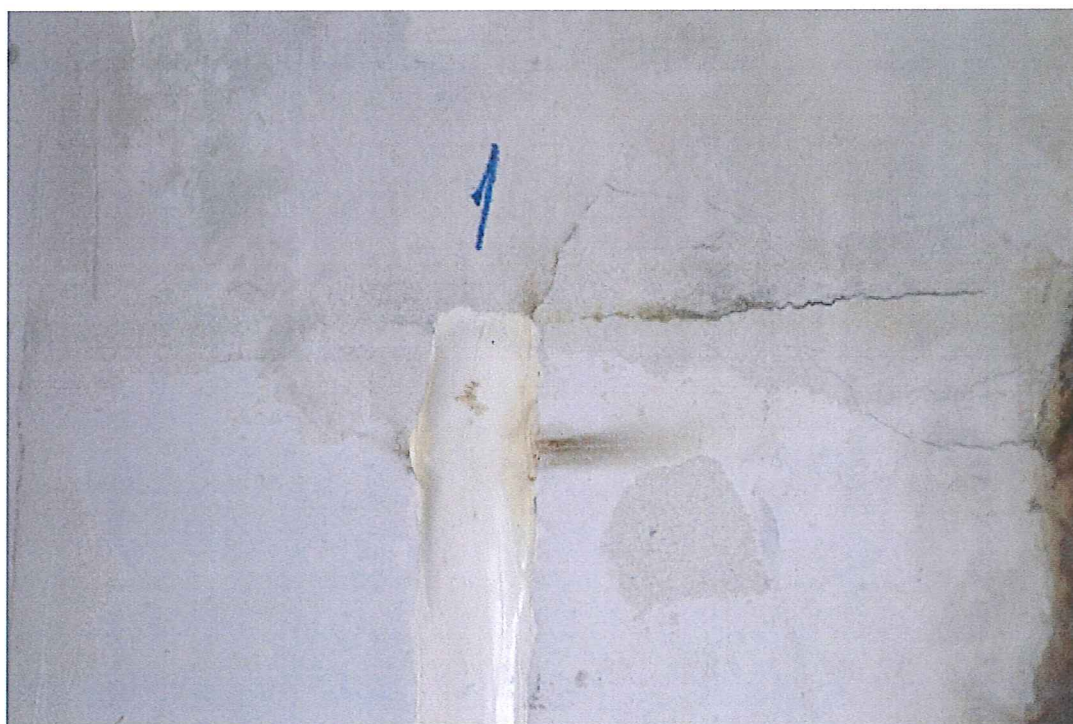
| 151 | 1 | Small opening along the top of sealant, weak smoke development. |
| 153 | 1 | Failure of integrity, due to trough going opening in the top of the sealant. |

Photo No. 14 Integrity failure at the top of joint seal 1 after 153 minutes of testing

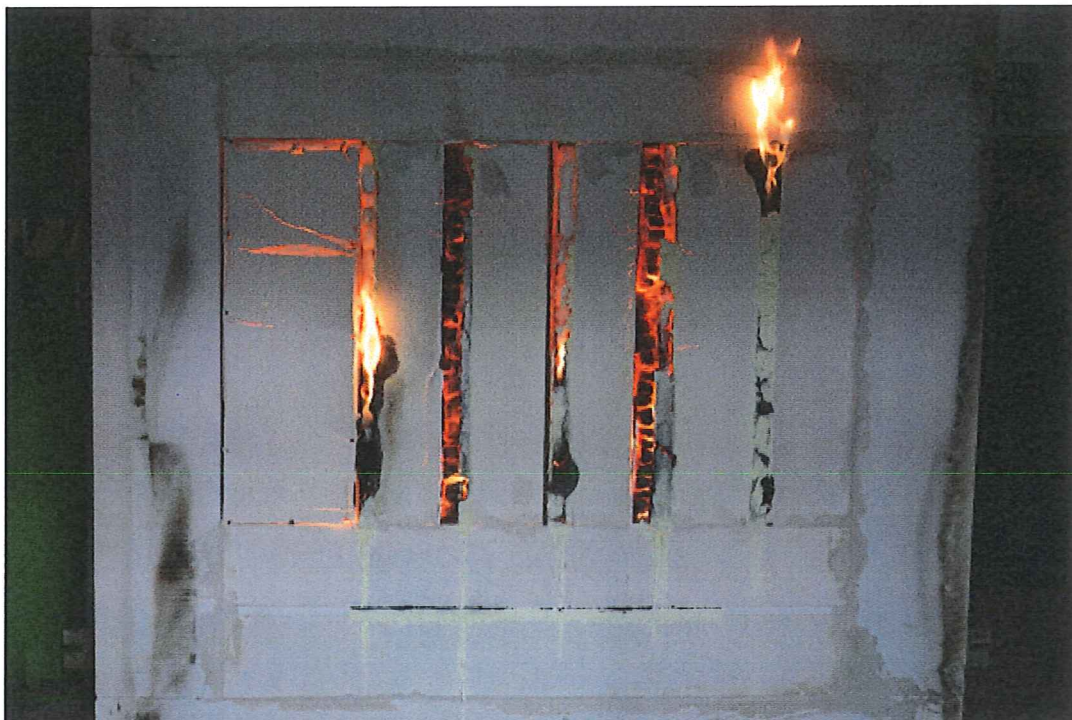
Photo No. 15 Exposed side of test specimen after the test

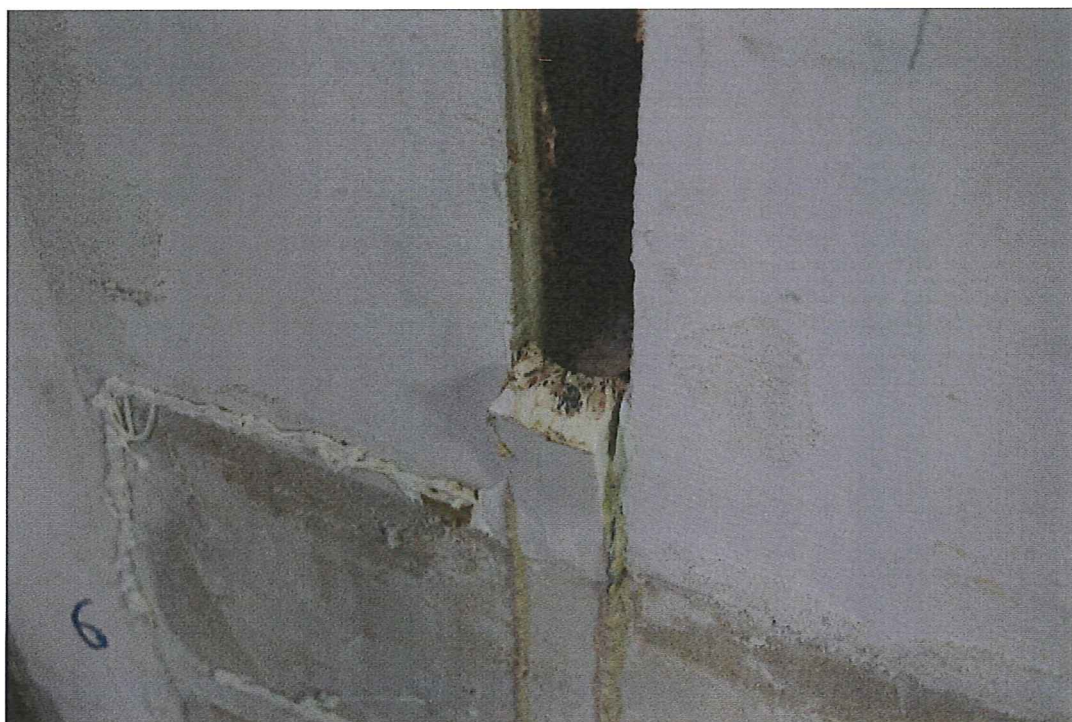
Photo No. 16 Bottom of joint seal 1 after the test
