The Fire Resistance
Performance Of Six
Specimens Of Wall
Mounted And Six
Specimens Of Floor
Mounted Linear Gap
Sealing Systems, Tested
In Accordance With BS
EN 1366-4: 2006

182724/A

Nullifire Limited

7th May 2009

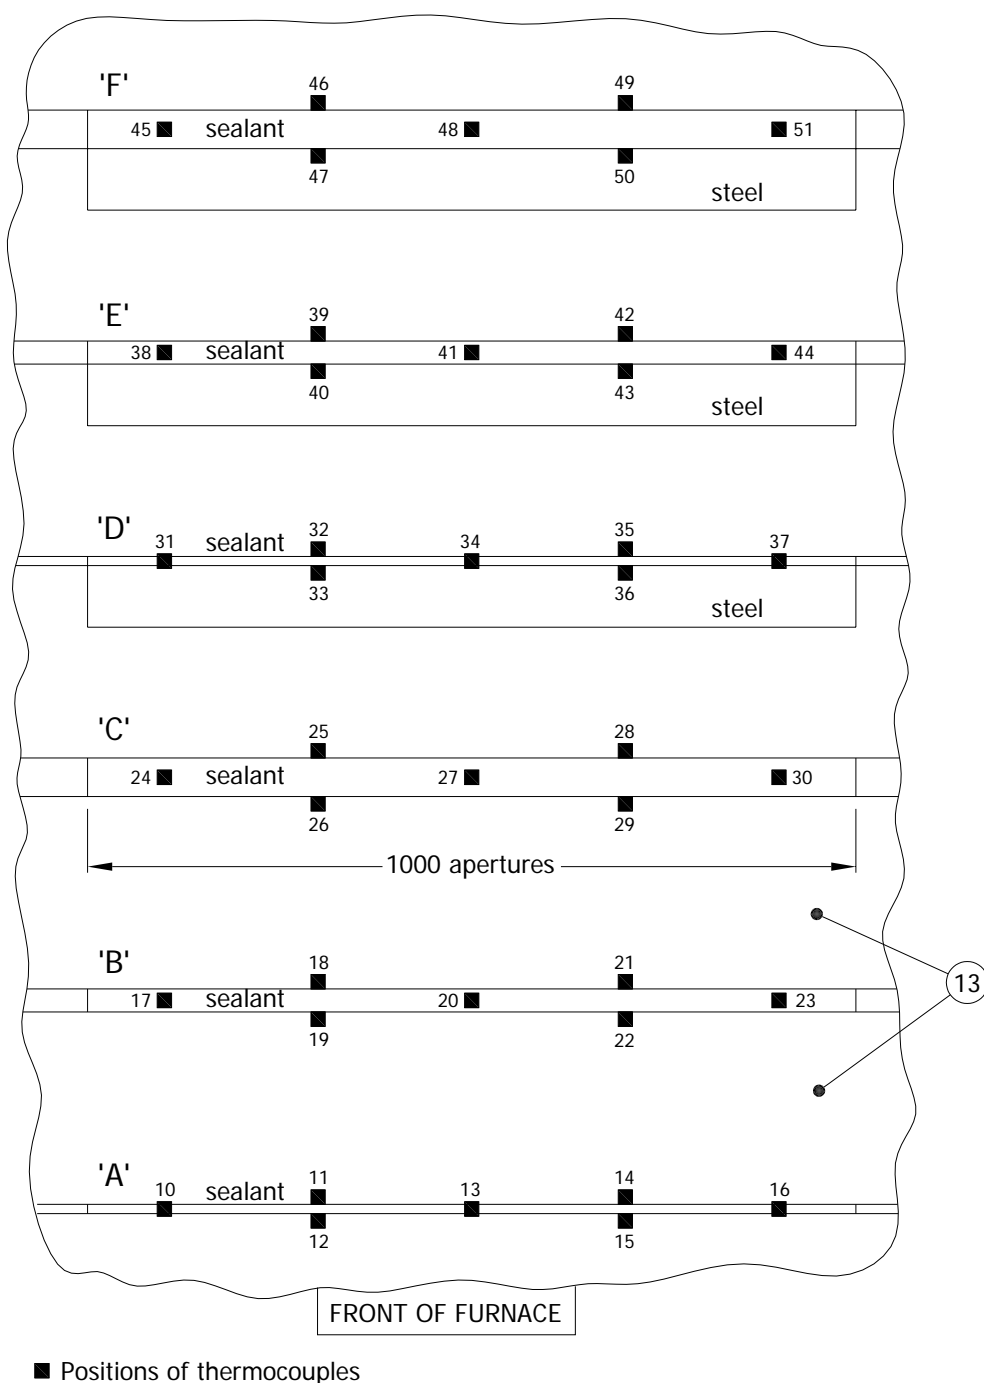
Figure 2 – Enlarged View showing Unexposed Face Thermocouples for Floor Test Specimens

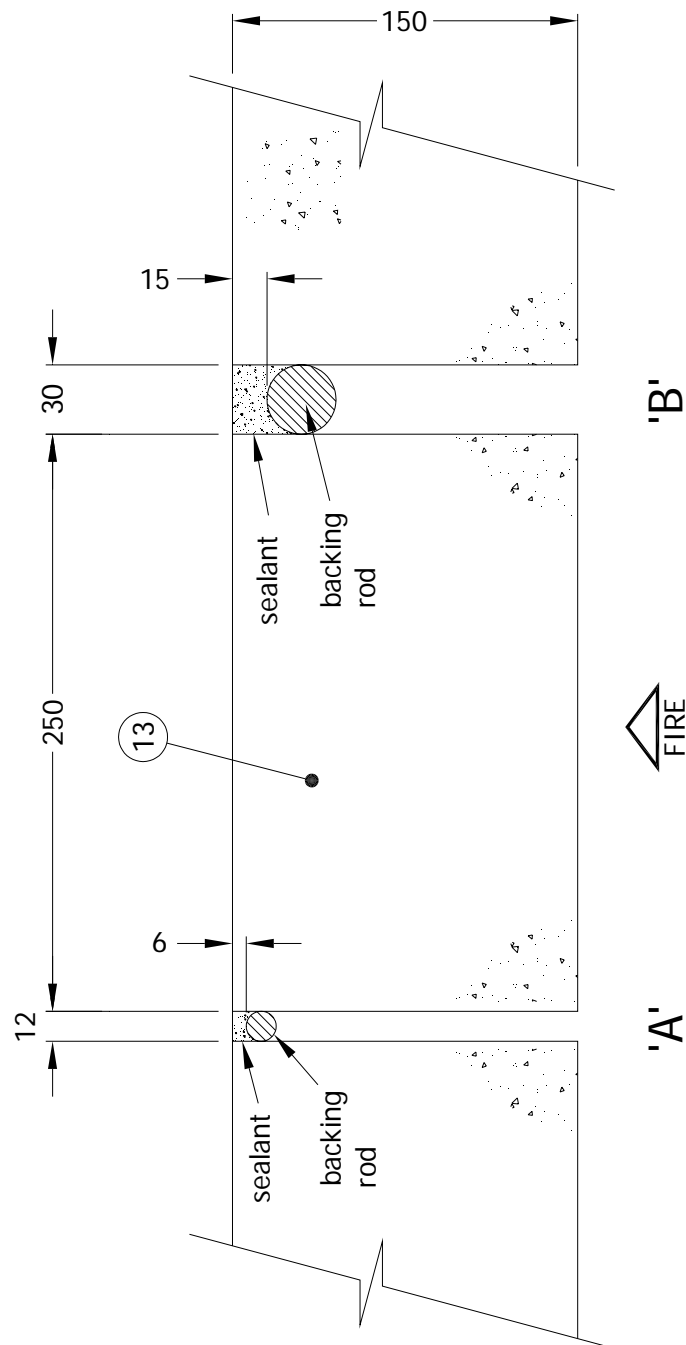
Figure 3 – Section Through Floor Specimens 'A' and 'B' (items 1 and 2)

<u>Item</u>	<u>Description</u>
Details of Floor Joint Seals (items 1 to 6)	
1. Specimen 'A'	
Details of Sealant	
Manufacturer	: Nullifire Limited
Reference	: M701 Intumescent Acrylic Sealant
Material	: Acrylic Sealant
Overall section size of sealant	: 12 mm wide x 6 mm deep x 1000 mm long
Application method	: Cartridge gunned at unexposed face of cavity
Overall size of cavity	: 12 mm wide x 150 mm deep x 1000 mm long
Details of Backing rod	
Material	: Polyethylene
Size	: 13 mm diameter
Fixing method	: Friction fit within cavity
Details of Gap facing	: Masonry (item 13)

2. Specimen 'B'	
Details of Sealant	
Manufacturer	: Nullifire Limited
Reference	: M701 Intumescent Acrylic Sealant
Material	: Acrylic Sealant
Overall section size of sealant	: 30 mm wide x 15 mm deep x 1000 mm long
Application method	: Cartridge gunned at unexposed face of cavity
Overall size of cavity	: 30 mm wide x 150 mm deep x 1000 mm long
Details of Backing rod	
Material	: Polyethylene
Size	: 30 mm diameter
Fixing method	: Friction fit within cavity
Details of Gap facing	: Masonry (item 13)

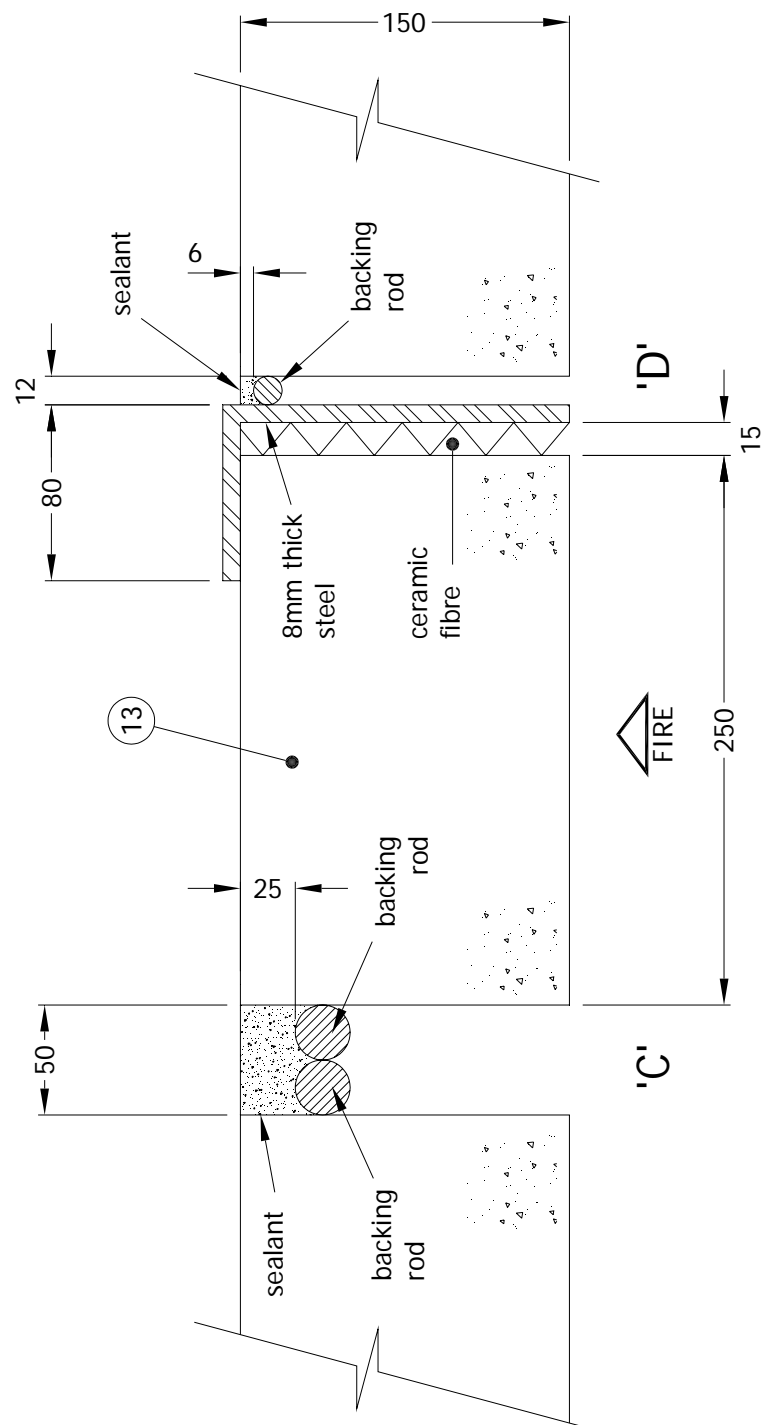
Figure 4 – Section Through Floor Specimens 'C' and 'D' (items 3 and 4)

3. Specimen 'C'	
Details of Sealant	
Manufacturer	: Nullifire Limited
Reference	: M701 Intumescent Acrylic Sealant
Material	: Acrylic Sealant
Overall section size of sealant	: 50 mm wide x 25 mm deep x 1000 mm long
Application method	: Cartridge gunned at unexposed face of cavity
Overall size of cavity	: 50 mm wide x 150 mm deep x 1000 mm long
Details of Backing rod	
Material	: Polyethylene
Size	: 2 no. rods, each 25 mm diameter
Fixing method	: Friction fit within cavity
Details of Gap facing	: Masonry (item 13)

Details of Sealant	
Manufacturer	: Nullifire Limited
Reference	: M701 Intumescent Acrylic Sealant
Material	: Acrylic Sealant
Overall section size of sealant	: 12 mm wide x 6 mm deep x 1000 mm long
Application method	: Cartridge gunned at unexposed face of cavity
Overall size of cavity	: 12 mm wide x 150 mm deep x 1000 mm long
Details of Backing rod	
Material	: Polyethylene
Size	: 13 mm diameter
Fixing method	: Friction fit within cavity
Details of Gap facing	: Steel/Masonry (item 13)
Details of steel	
Thickness	: 8 mm
Fixing method to masonry	: 3 no. 5.5 mm diameter x 75 mm long screws
Details of insulation infill	
Material	: Ceramic fibre insulation
Fixing method	: Friction fit within void behind steel facing. See Figure 4.

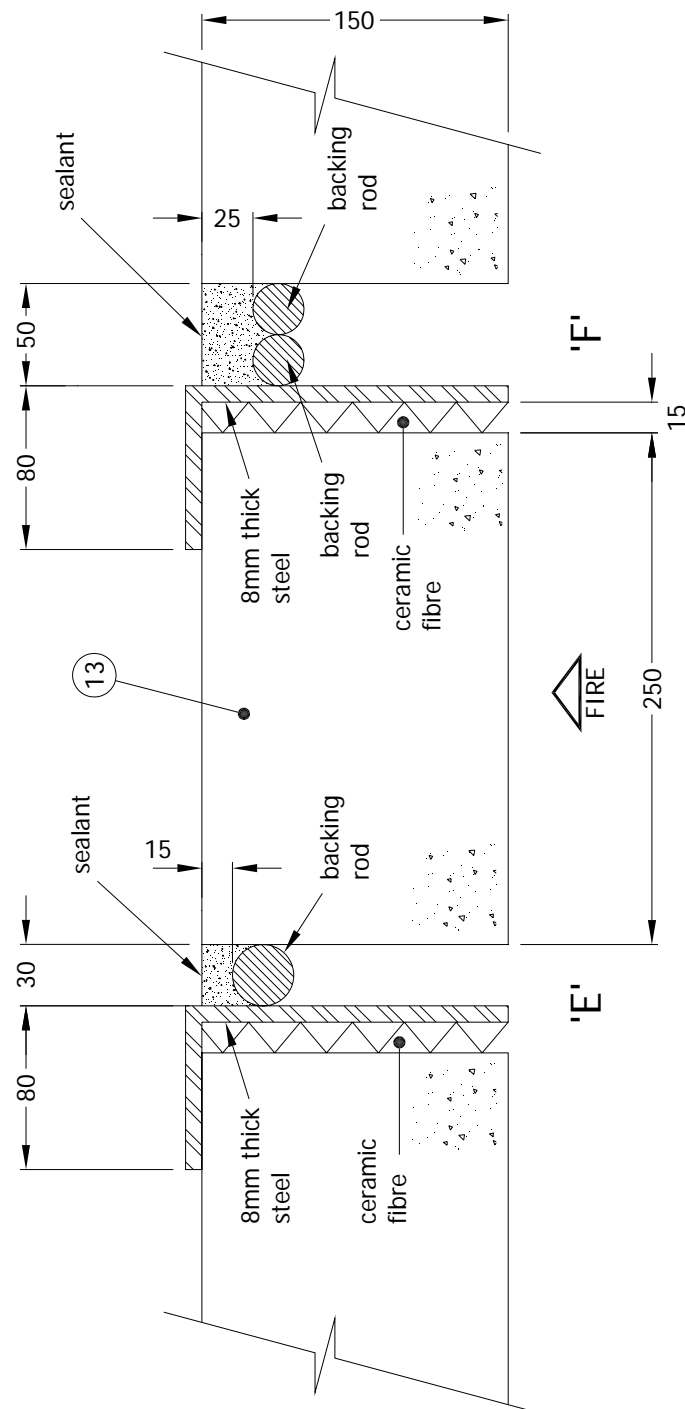
Figure 5 – Section Through Floor Specimens 'E' and 'F' (items 5 and 6)

Details of Sealant	
Manufacturer	: Nullifire Limited
Reference	: M701 Intumescent Acrylic Sealant
Material	: Acrylic Sealant
Overall section size of sealant	: 30 mm wide x 15 mm deep x 1000 mm long
Application method	: Cartridge gunned at unexposed face of cavity
Overall size of cavity	: 30 mm wide x 150 mm deep x 1000 mm long
Details of Backing rod	
Material	: Polyethylene
Size	: 30 mm diameter
Fixing method	: Friction fit within cavity
Details of Gap facing	: Steel/Masonry (item 13)
Details of steel	
Thickness	: 8 mm
Fixing method to masonry	: 3 no. 5.5 mm diameter x 75 mm long screws
Details of insulation infill	
Material	: Ceramic fibre insulation
Fixing method	: Friction fit within void behind steel facing. See Figure 5.

<u>Item</u>	<u>Description</u>
6. continued	
Fixing method	: Friction fit within cavity
Details of Gap facing	: Steel/Masonry (item 13)
Details of steel	
Thickness	: 8 mm
Fixing method to masonry	: 3 no. 5.5 mm diameter x 75 mm long screws
Details of insulation infill	
Material	: Ceramic fibre insulation
Fixing method	: Friction fit within void behind steel facing. See Figure 5.

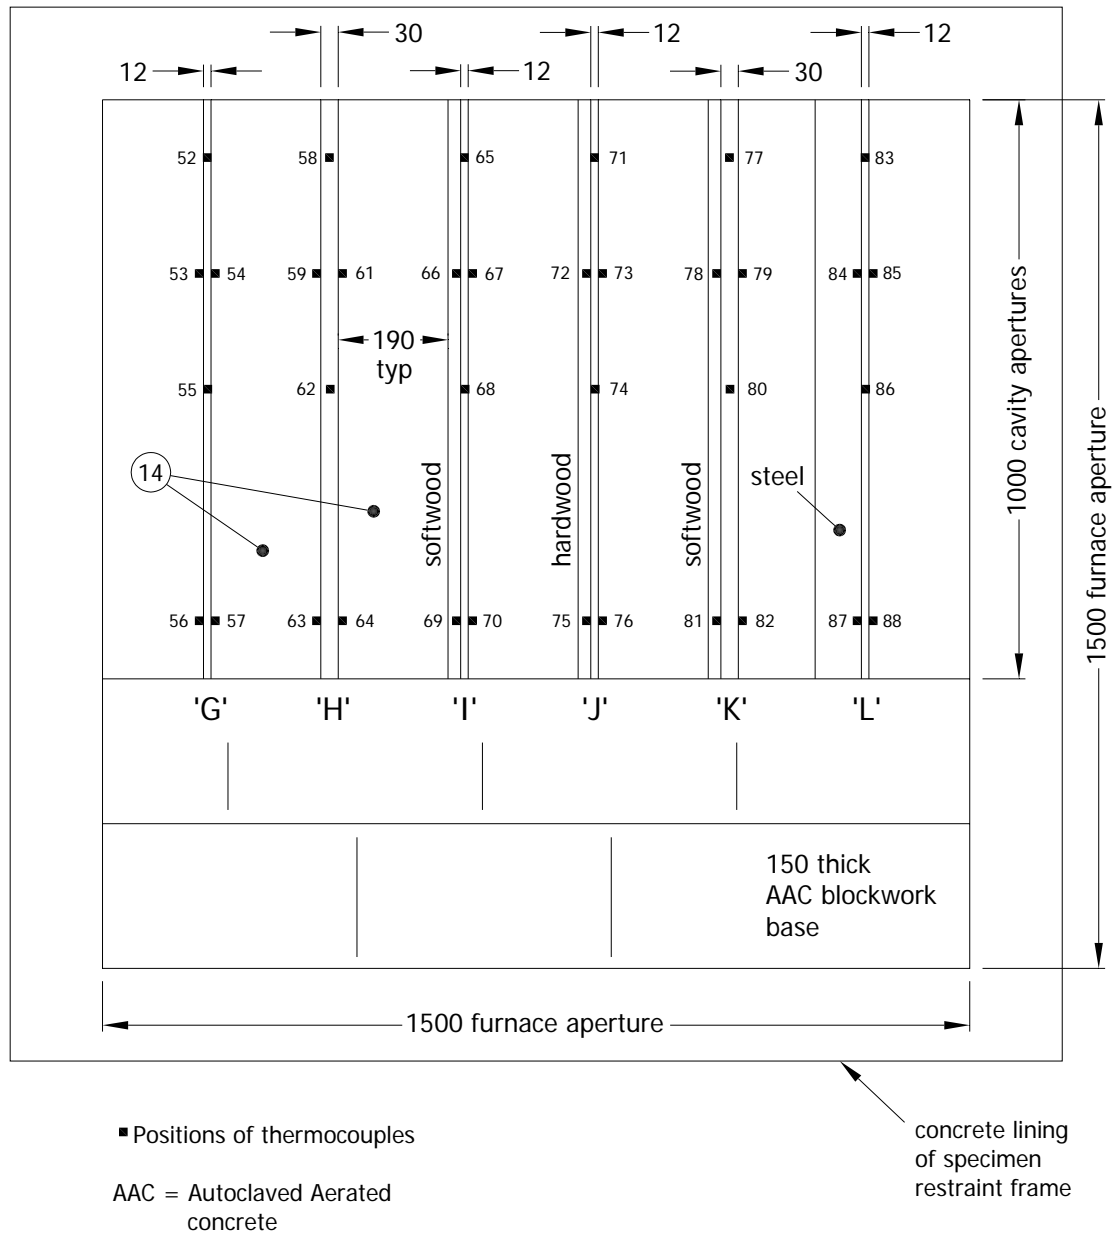
Figure 6 – General Elevation of Wall Test Specimens and Thermocouples at Unexposed Face

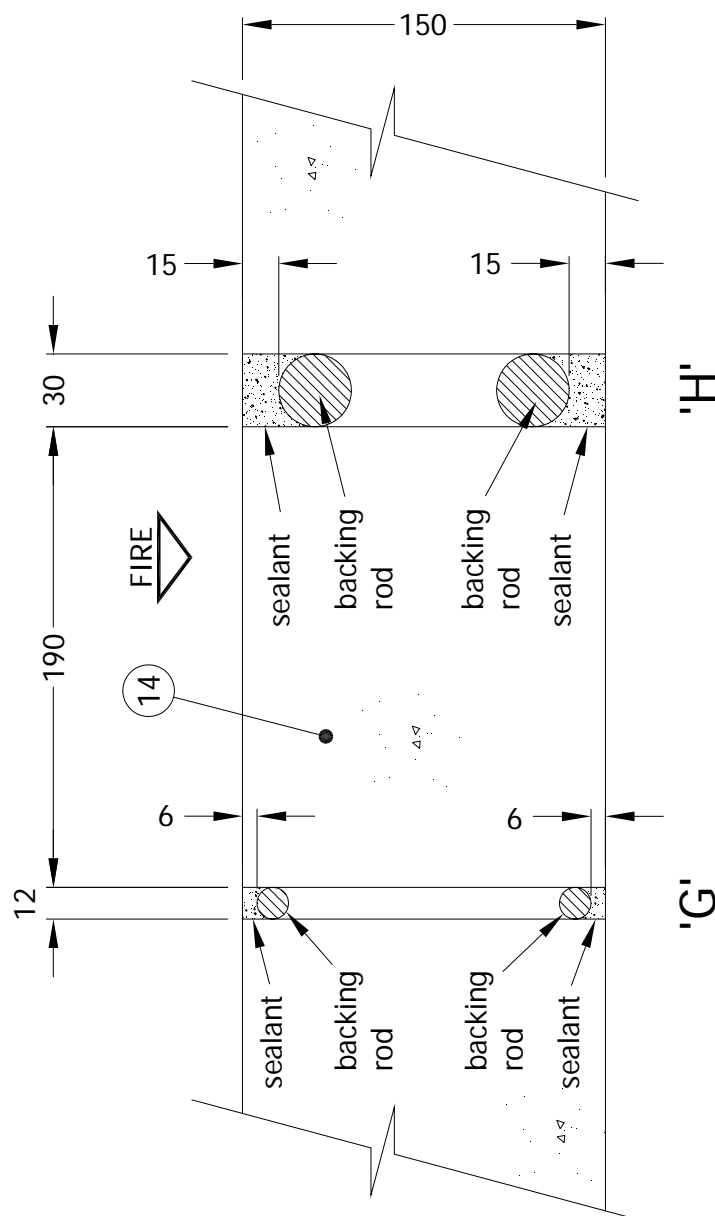
Figure 7 – Section Through Wall Specimens 'G' and 'H' (items 7 and 8)

Details of Sealant	
Manufacturer	: Nullifire Limited
Reference	: M701 Intumescent Acrylic Sealant
Material	: Acrylic Sealant
Overall section size of sealant	: 12 mm wide x 6 mm deep x 1000 mm long
Application method	: Cartridge gunned at both faces of cavity
Overall size of cavity	: 12 mm wide x 150 mm deep x 1000 mm long
Details of Backing rod	
Material	: Polyethylene
Size	: 13 mm diameter
Fixing method	: Friction fit within cavity
Details of Gap facing	: Masonry (item 14)

Details of Sealant	
Manufacturer	: Nullifire Limited
Reference	: M701 Intumescent Acrylic Sealant
Material	: Acrylic Sealant
Overall section size of sealant	: 30 mm wide x 15 mm deep x 1000 mm long
Application method	: Cartridge gunned at both faces of cavity
Overall size of cavity	: 30 mm wide x 150 mm deep x 1000 mm long
Details of Backing rod	
Material	: Polyethylene
Size	: 30 mm diameter
Fixing method	: Friction fit within cavity
Details of Gap facing	: Masonry (item 14)

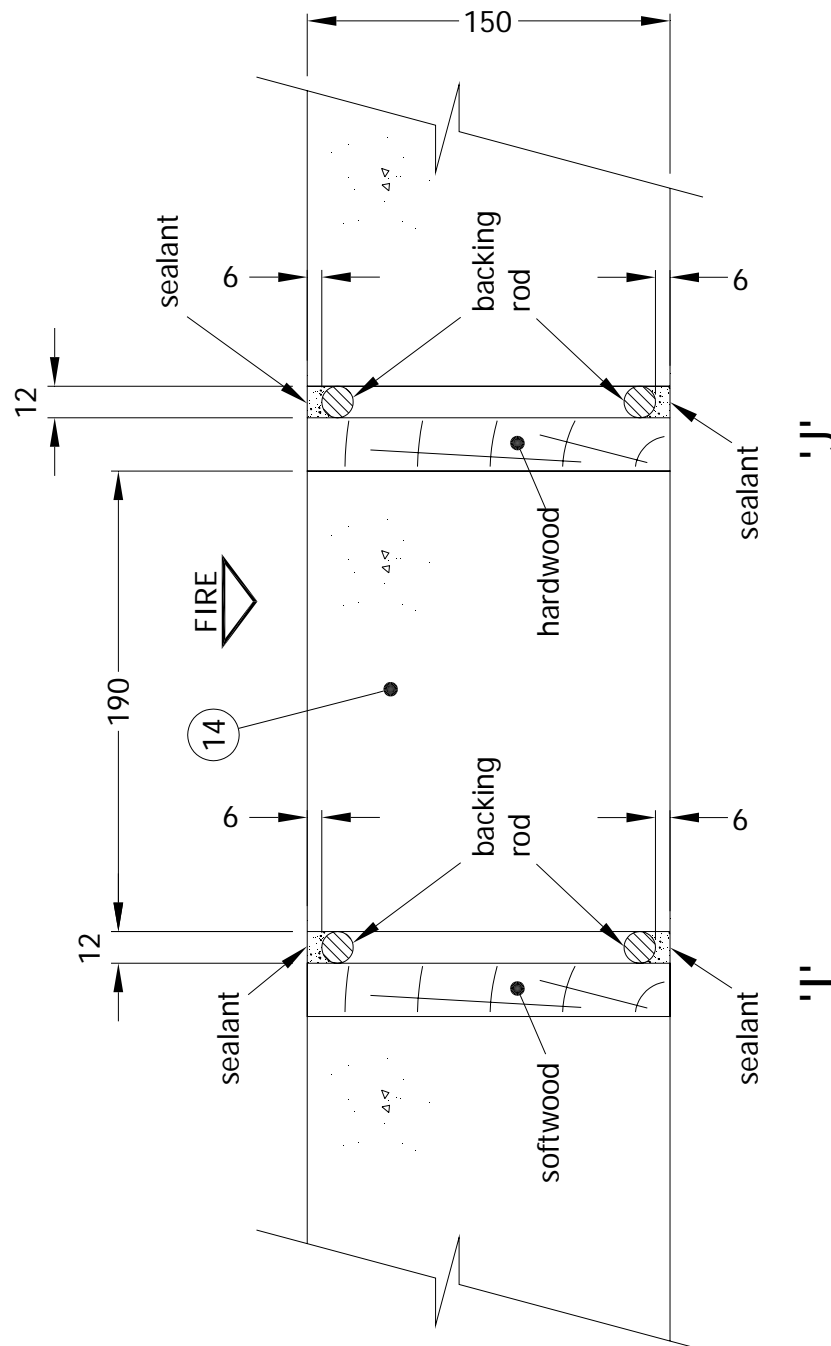
Figure 8 – Section Through Wall Specimens 'I' and 'J' (items 9 and 10)

Details of Sealant	
Manufacturer	: Nullifire Limited
Reference	: M701 Intumescent Acrylic Sealant
Material	: Acrylic Sealant
Overall section size of sealant	: 12 mm wide x 6 mm deep x 1000 mm long
Application method	: Cartridge gunned at both faces of cavity
Overall size of cavity	: 12 mm wide x 150 mm deep x 1000 mm long
Details of Backing rod	
Material	: Polyethylene
Size	: 13 mm diameter
Fixing method	: Friction fit within cavity
Details of Gap facing	: Timber/Masonry (item 14)

Manufacturer	:	Nullifire Limited
Reference	:	M701 Intumescent Acrylic Sealant
Material	:	Acrylic Sealant
Overall section size of sealant	:	12 mm wide x 6 mm deep x 1000 mm long
Application method	:	Cartridge gunned at both faces of cavity
Overall size of cavity	:	12 mm wide x 150 mm deep x 1000 mm long
Details of Backing rod		
Material	:	Polyethylene
Size	:	13 mm diameter
Fixing method	:	Friction fit within cavity
Details of Gap facing	:	Timber/Masonry (item 14)
Details of Timber		
Material	:	Hardwood
Thickness	:	22 mm
Fixing method to masonry	:	6 no. screws

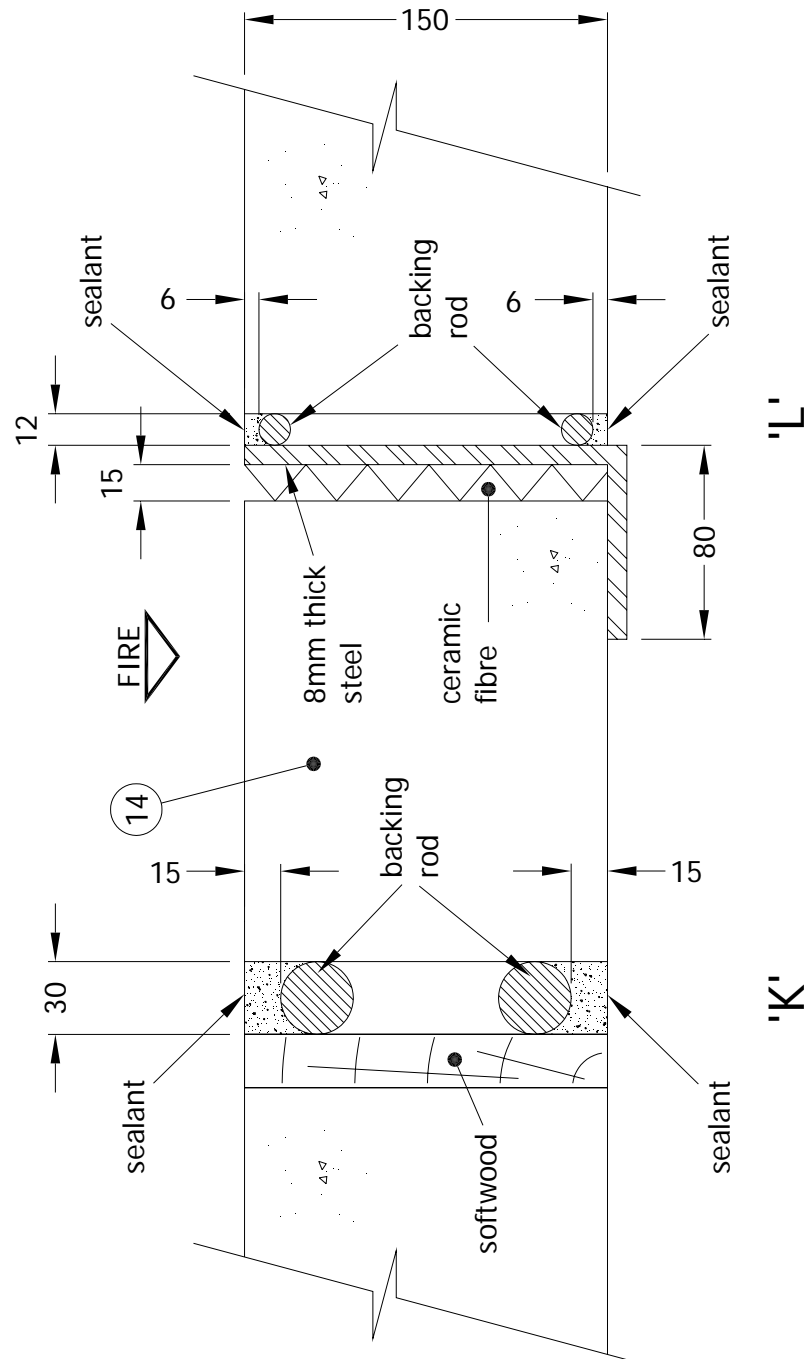
Figure 9 – Section Through Wall Specimens 'K' and 'L' (items 11 and 12)

Manufacturer	:	Nullifire Limited
Reference	:	M701 Intumescent Acrylic Sealant
Material	:	Acrylic Sealant
Overall section size of sealant	:	30 mm wide x 15 mm deep x 1000 mm long
Application method	:	Cartridge gunned at both faces of cavity
Overall size of cavity	:	30 mm wide x 150 mm deep x 1000 mm long
Details of Backing rod		
Material	:	Polyethylene
Size	:	30 mm diameter
Fixing method	:	Friction fit within cavity
Details of Gap facing	:	Timber/Masonry (item 14)
Details of Timber		
Material	:	Softwood
Thickness	:	22 mm
Fixing method to masonry	:	6 no. screws

Manufacturer	:	Nullifire Limited
Reference	:	M701 Intumescent Acrylic Sealant
Material	:	Acrylic Sealant
Overall section size of sealant	:	12 mm wide x 6 mm deep x 1000 mm long
Application method	:	Cartridge gunned at both faces of cavity
Overall size of cavity	:	12 mm wide x 150 mm deep x 1000 mm long

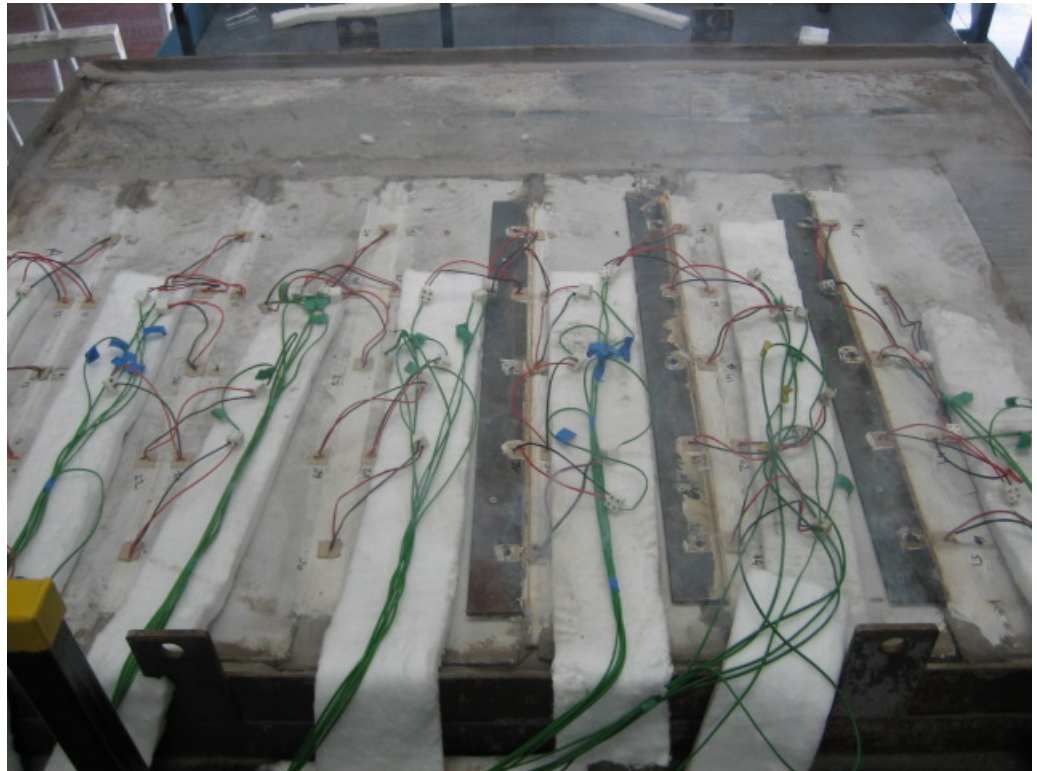
The unexposed
face of the floor
construction
after 60 minutes
of testing

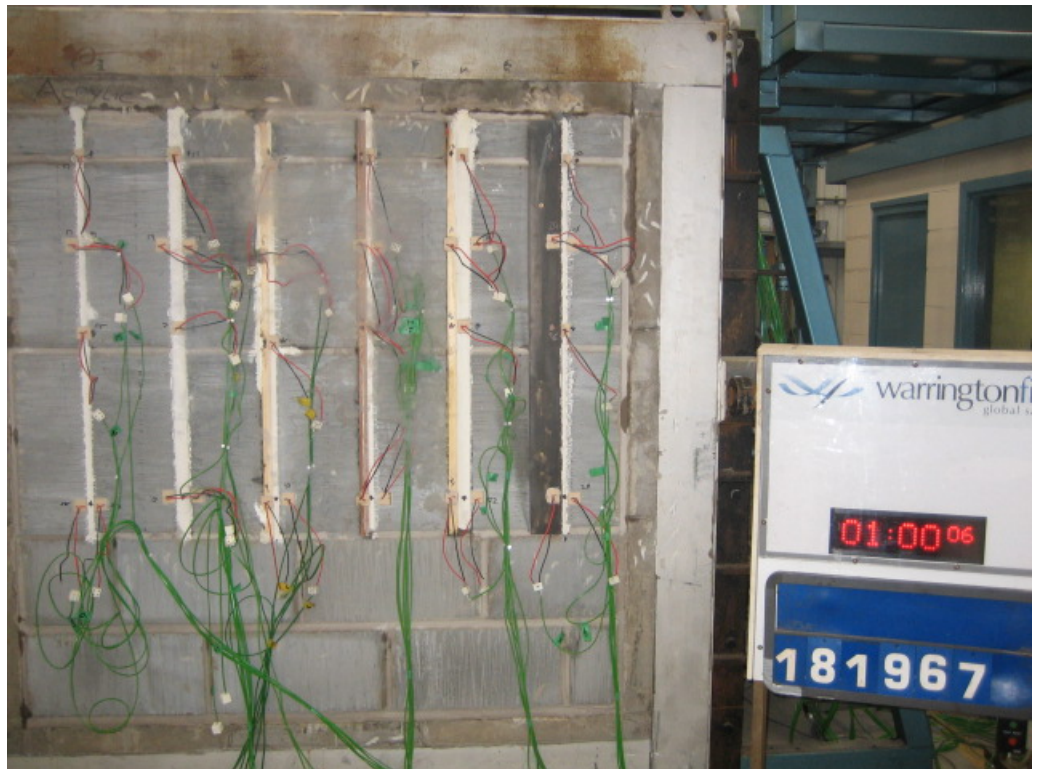
The unexposed
face of the wall
construction
after 60 minutes
of testing

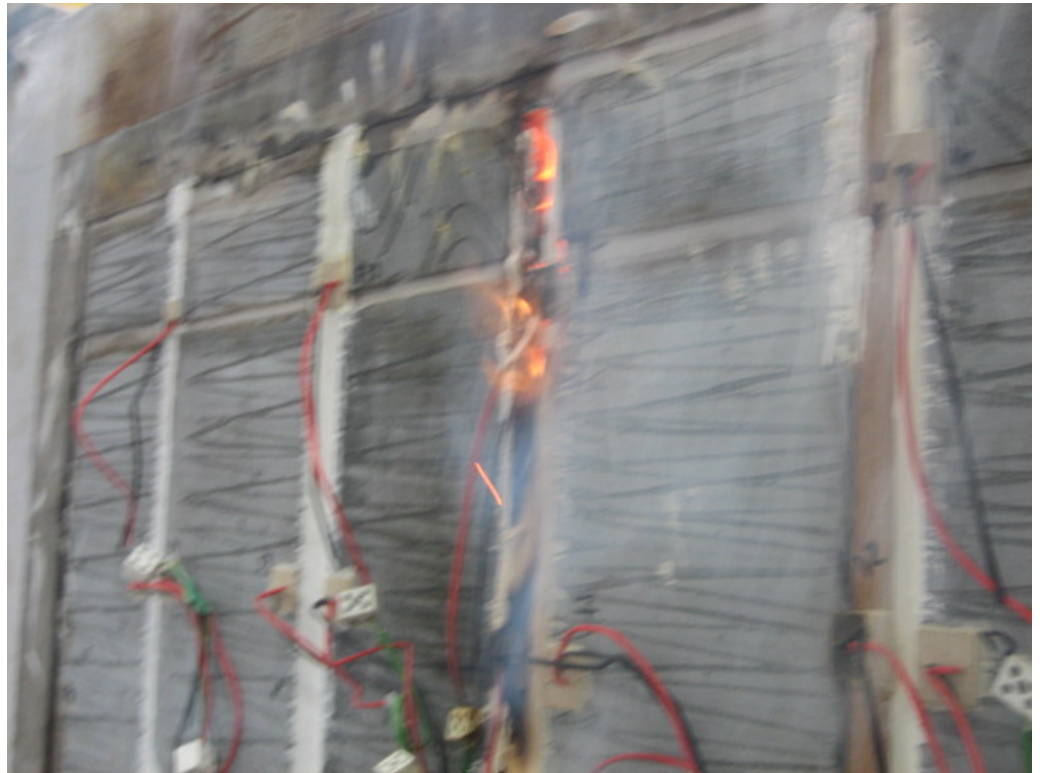
**Sustained
flaming integrity
failure of
Specimen I after
108 minutes of
testing**

108	00	A sustained flame is visible at the head of Specimen I as the timber substrate ignites. Sustained flame integrity failure of Specimen I is deemed to occur. An area of glowing is visible between the timber substrate and the seal of Specimen K. A cotton pad is applied but fails to ignite.
113	00	Flames spread along the timber substrate of Specimen I, the specimen is blanked off to allow the test to continue.
114	30	A cotton pad is applied to the area of glowing at the head of Specimen K and ignites. On removal of the pad a sustained flames is evident from the same location. Cotton pad and sustained flaming integrity failure of Specimen K is deemed to occur. The specimen is blanked off to allow the test to continue.
120	00	All specimens excluding Specimens I and K continue to satisfy the integrity criteria.
130	00	Brown discolouration spreads throughout the seals of Specimens B to F of the floor construction.

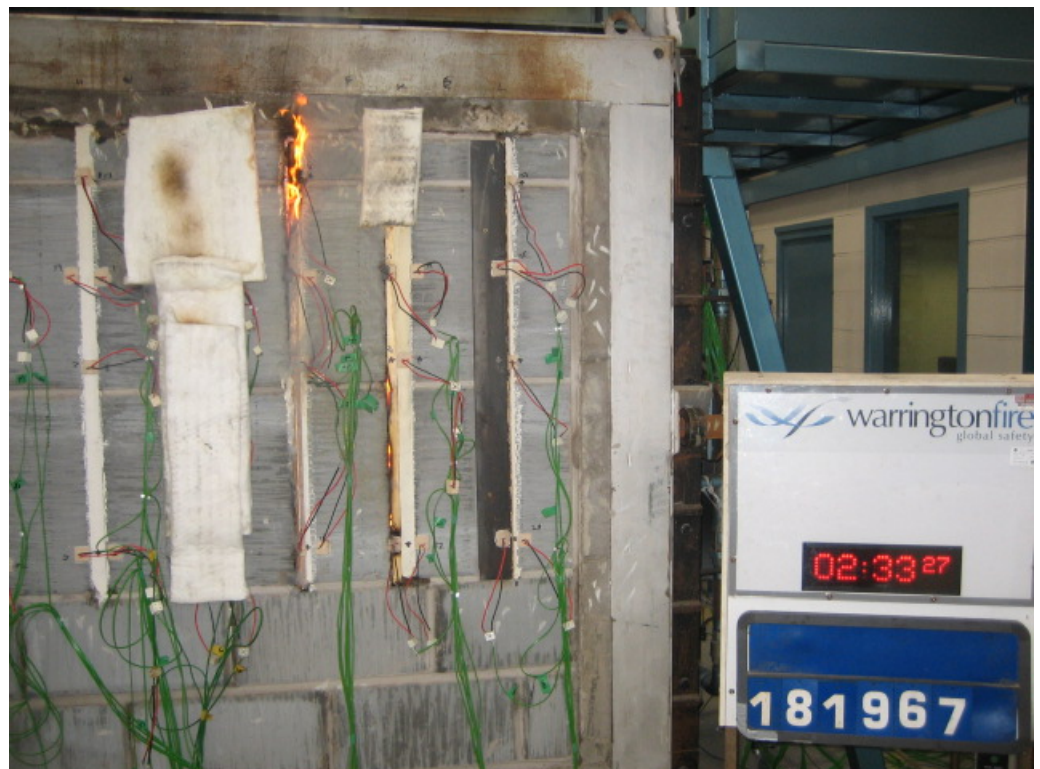
**The unexposed
face of the wall
construction
after 153
minutes of
testing**

152	00	Thermocouple number 71 of Specimen J records a temperature rise in excess of 180° C. Insulation failure of Specimen J is deemed to occur.
153	00	A sustained flame is visible at the head of Specimen J as the timber substrate burns through and ignites. Cotton pad and sustained flaming integrity failure of Specimen J is deemed to occur. The specimen is blanked off to allow the test to continue.
164	00	Smoke release has reduced significantly from Specimens G to L.

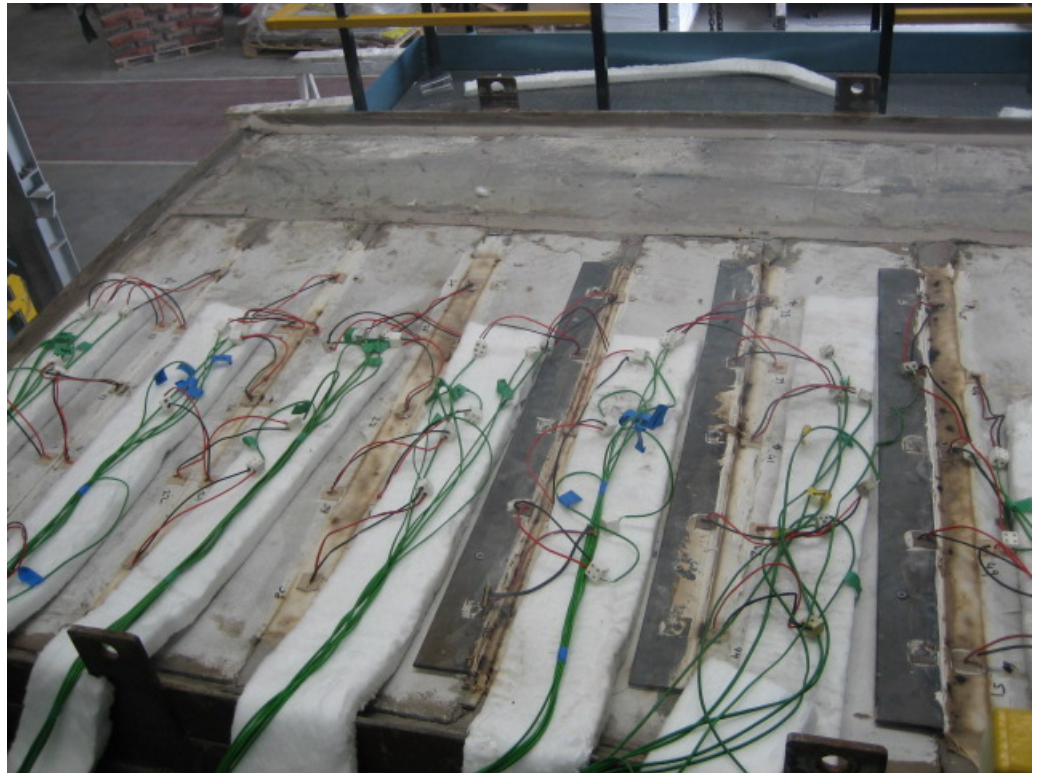
The unexposed
face of the floor
construction
after 153
minutes of
testing

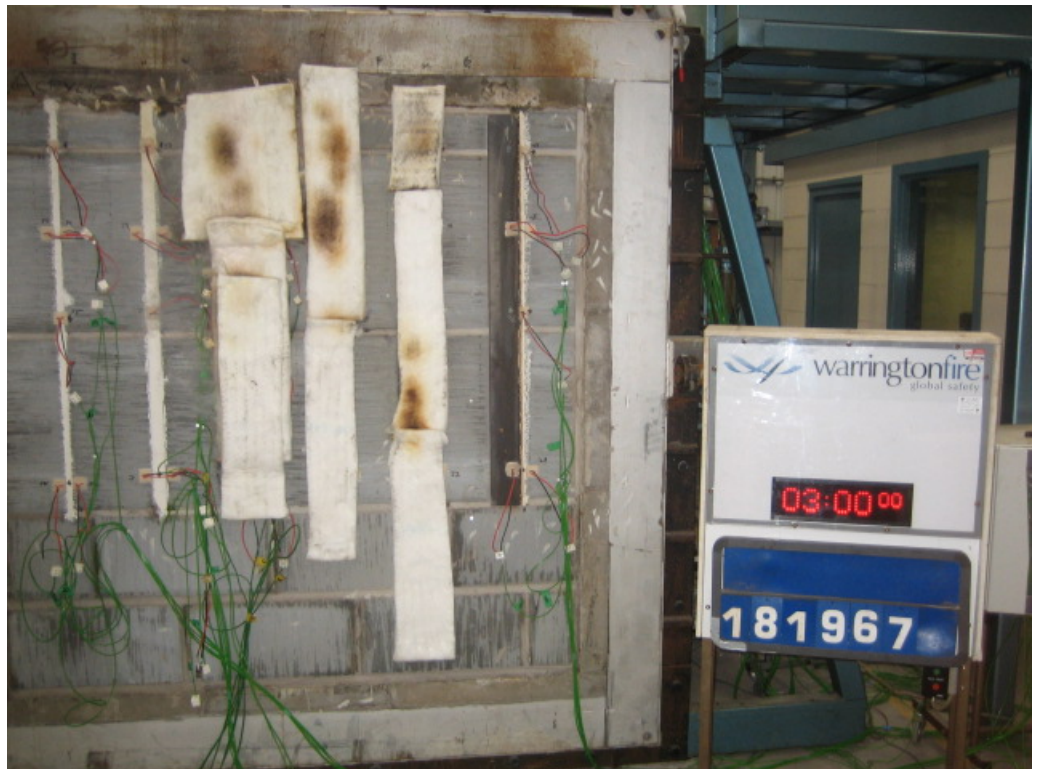
The unexposed
face of the wall
construction
after 180
minutes of
testing

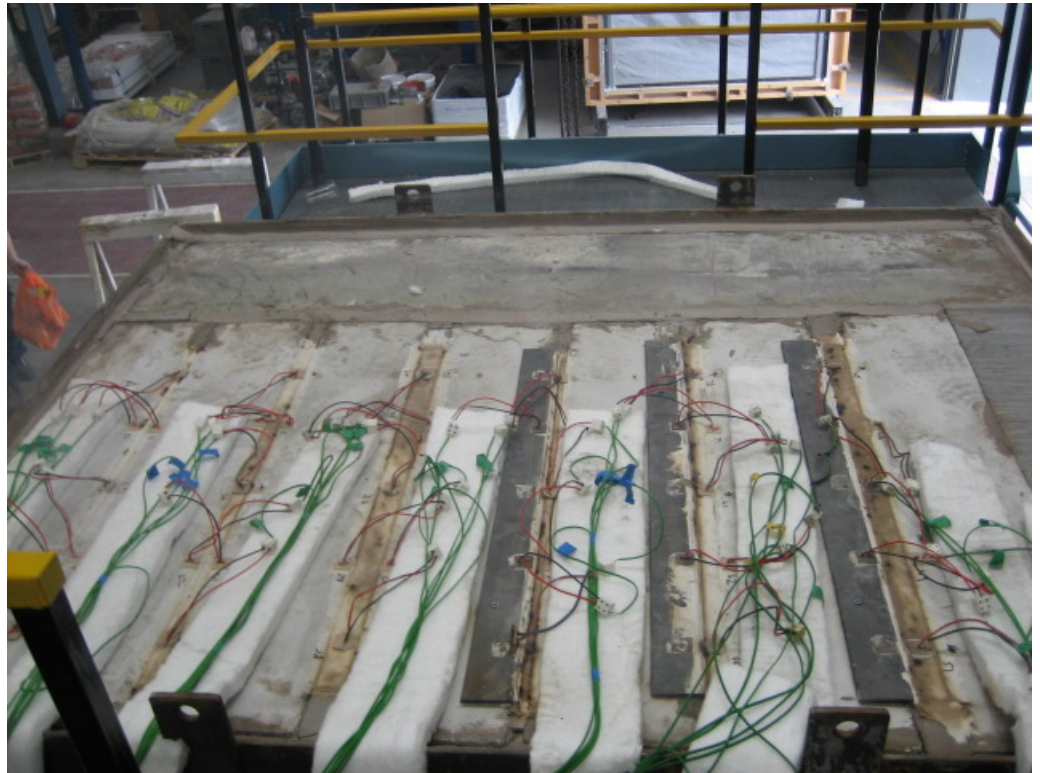
The unexposed
face of the floor
construction
after 180
minutes of
testing

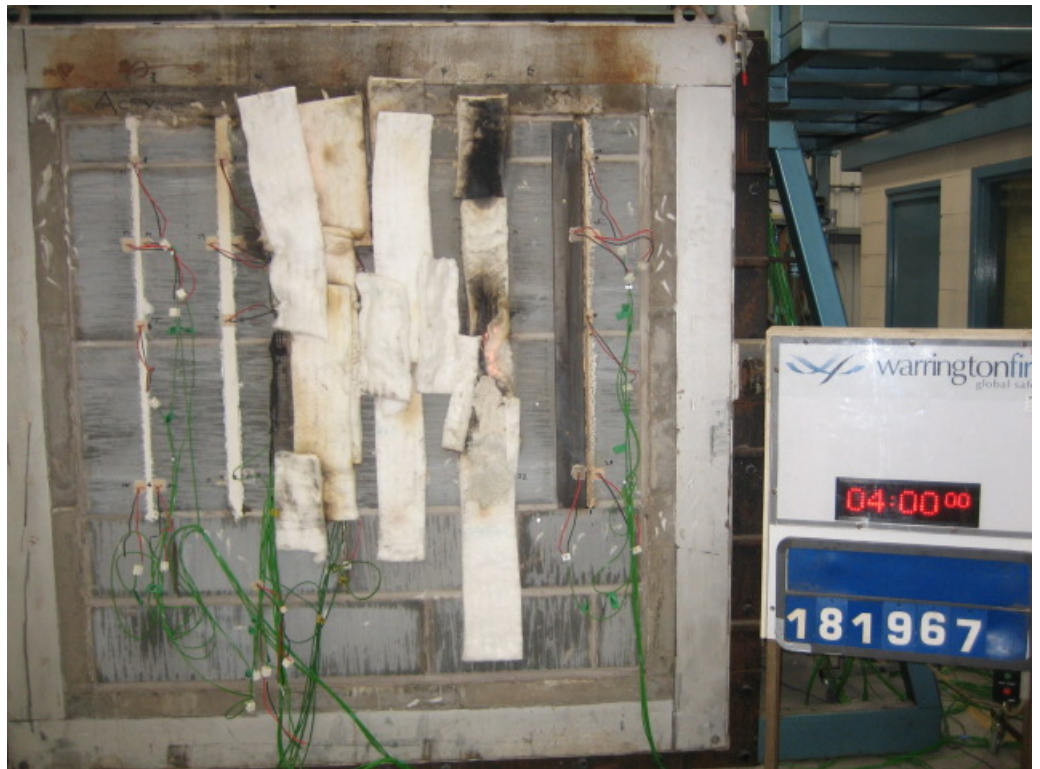
The unexposed
face of the wall
construction
after 240
minutes of
testing

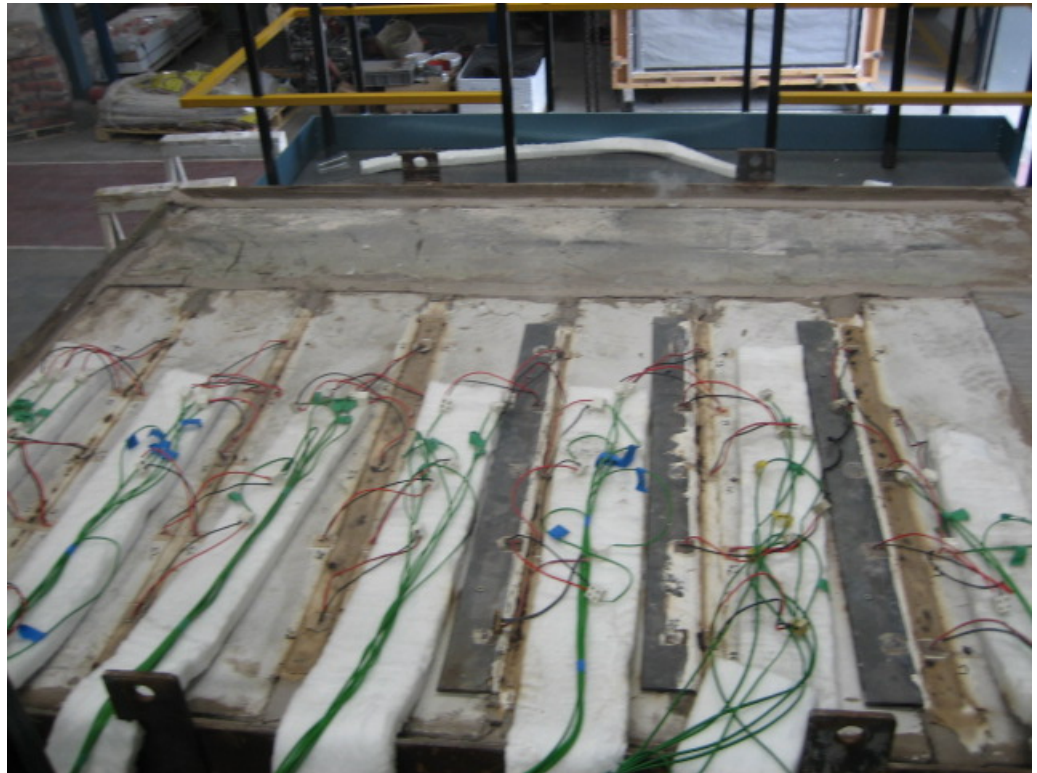
The unexposed
face of the floor
construction
after 240
minutes of
testing

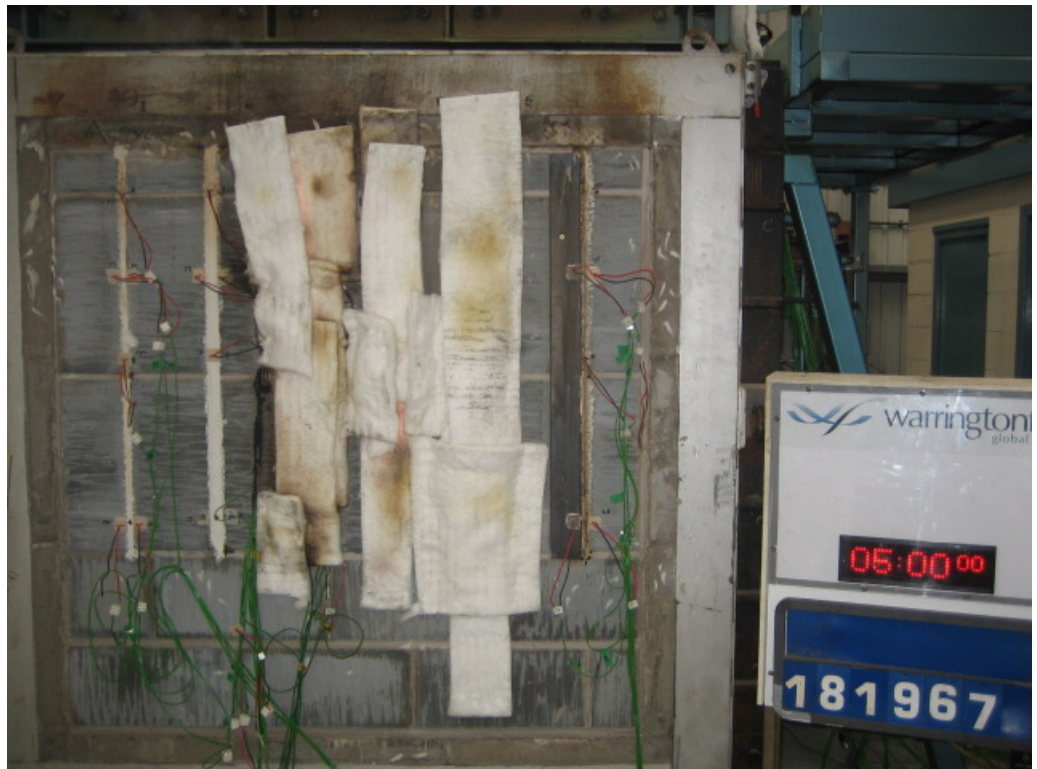
The unexposed
face of the wall
construction
after 300
minutes of
testing

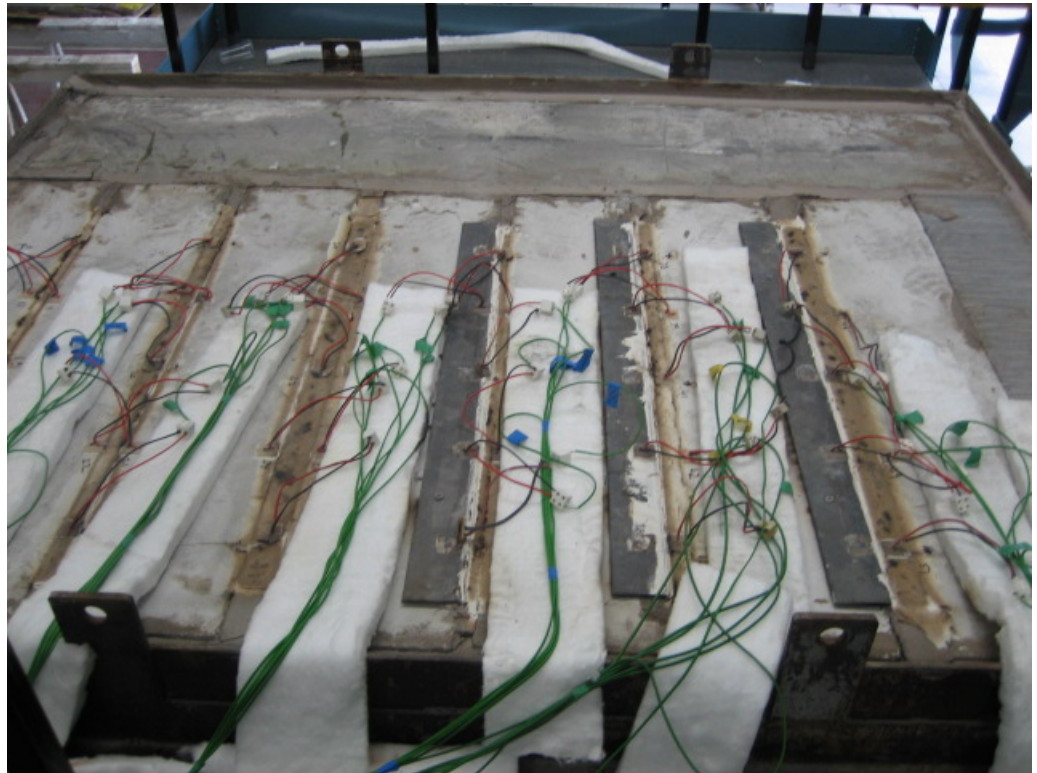
The unexposed
face of the floor
construction
after 300
minutes of
testing

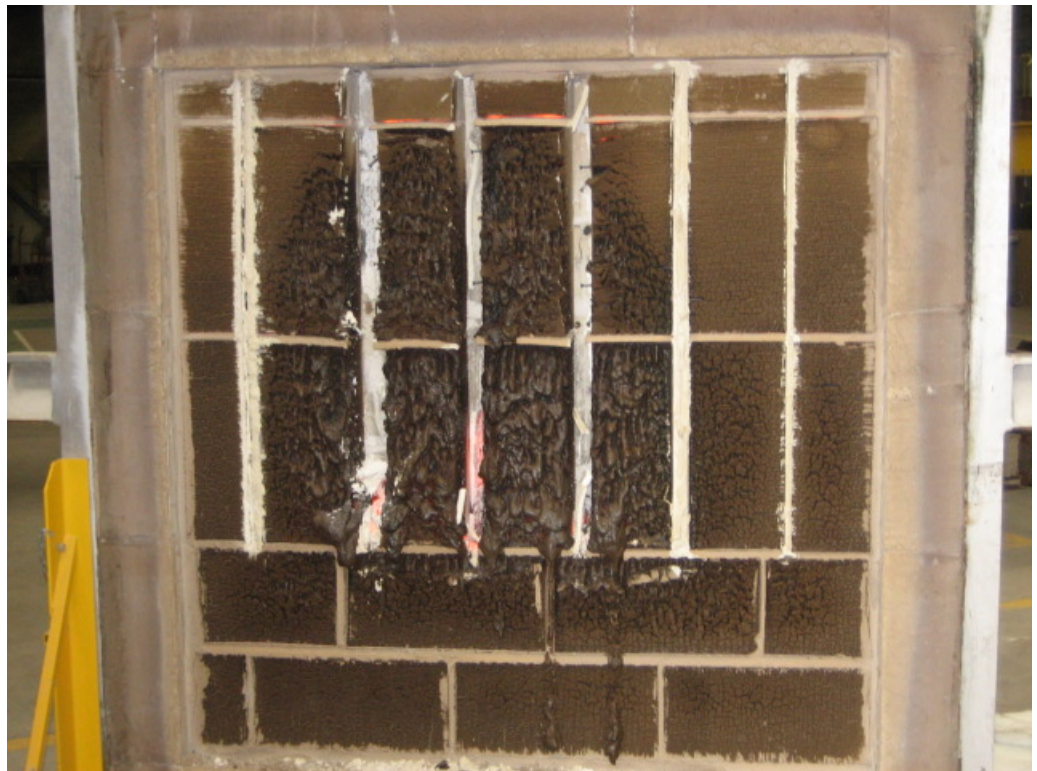
The exposed face
of the wall
construction
immediately after
testing

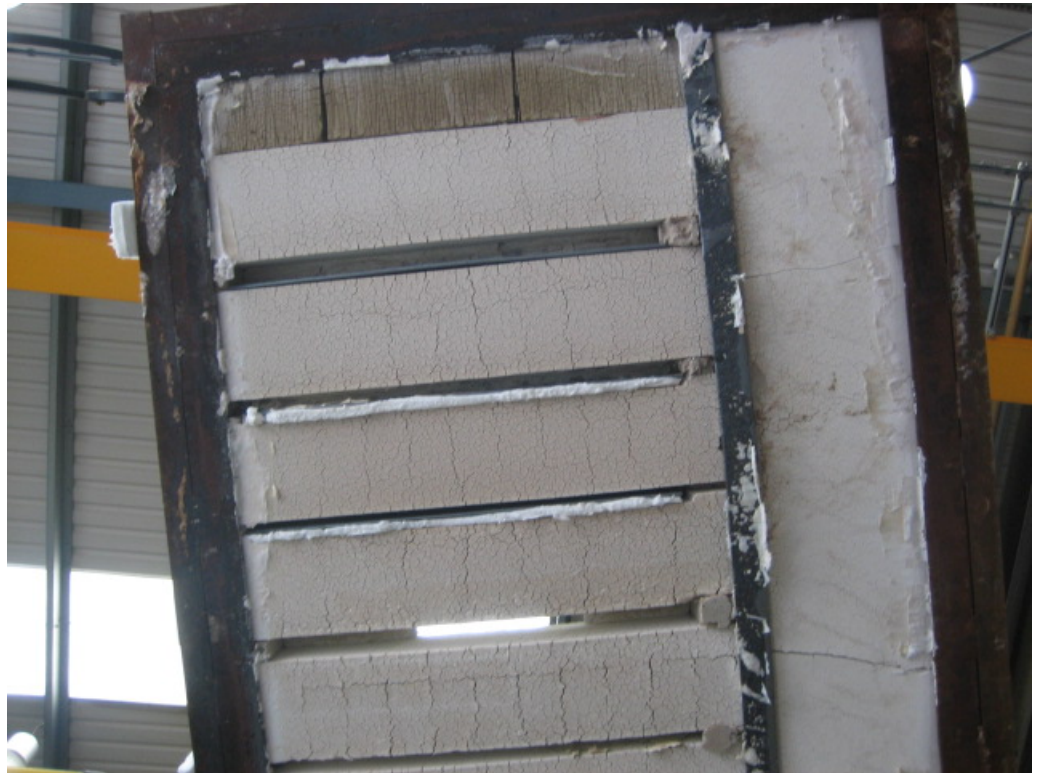
The exposed face
of the floor
construction
after testing
