The Fire Resistance
Performance Of Six
Specimens Of Wall
Mounted And Six
Specimens Of Floor
Mounted Linear Gap
Sealing Systems, Tested
In Accordance With BS
EN 1366-4: 2006

182724/A

Nullifire Limited

7th May 2009

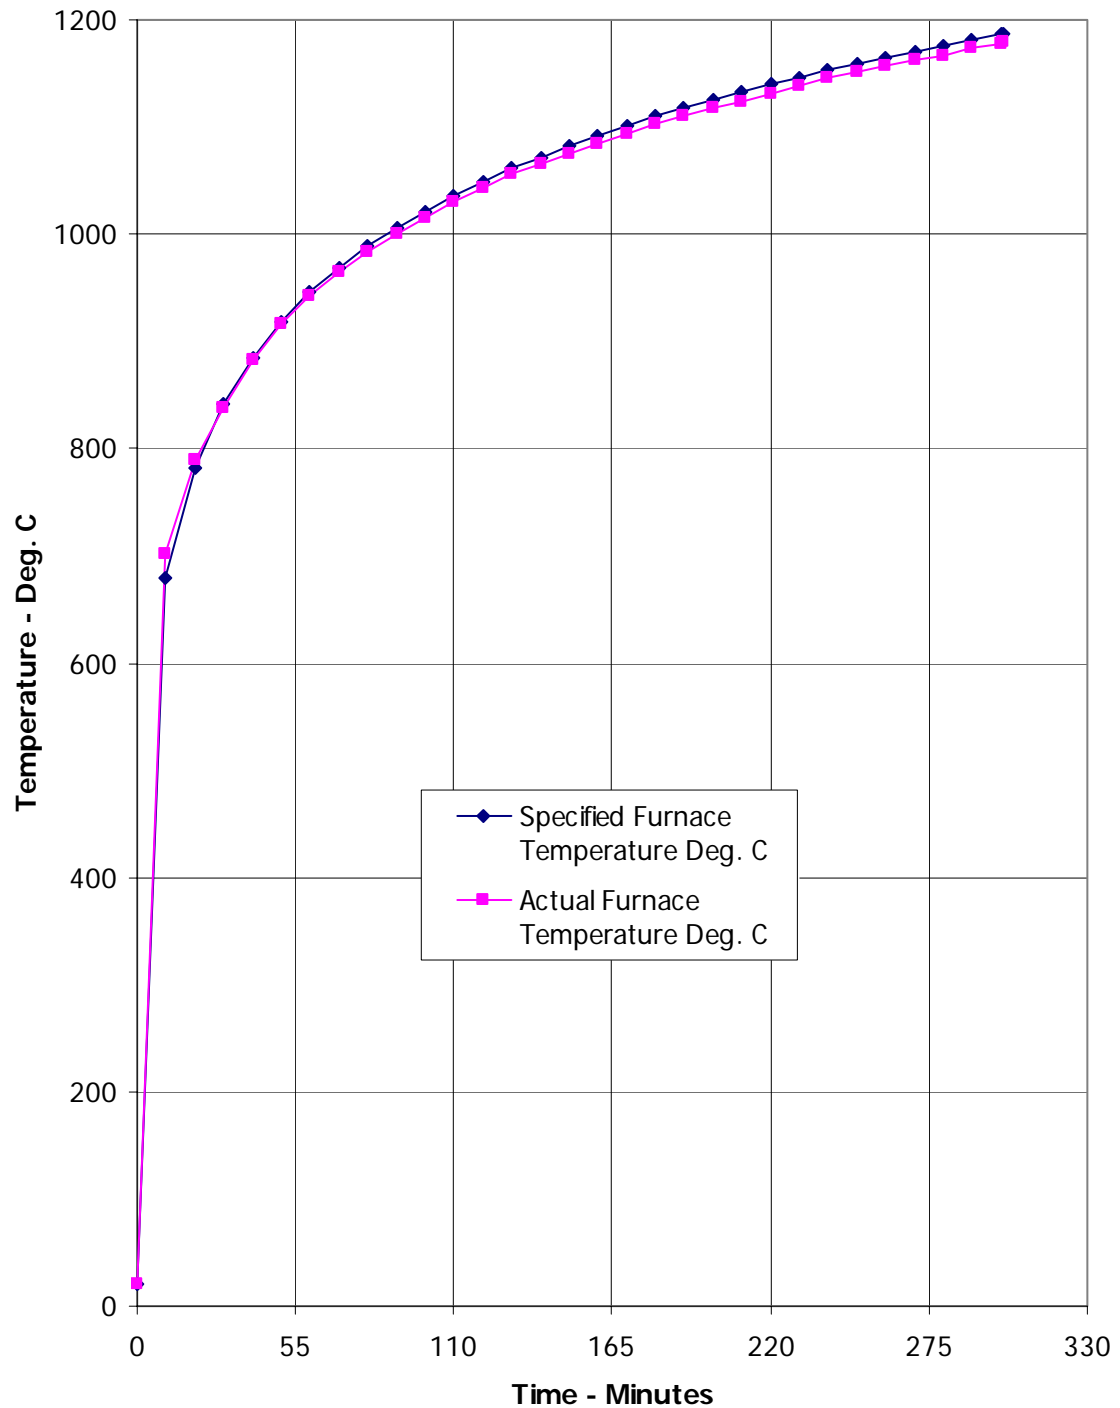
Graph Showing Mean Furnace Temperature, Together With The Temperature/Time Relationship Specified In The Standard

Time Mins	Specified Furnace Temperature Deg. C	Actual Furnace Temperature Deg. C
0	20	20
10	678	701
20	781	789
30	842	839
40	885	882
50	918	916
60	945	943
70	968	966
80	988	984
90	1006	1001
100	1022	1016
110	1036	1030
120	1049	1043
130	1061	1056
140	1072	1066
150	1082	1076
160	1092	1084
170	1101	1094
180	1110	1103
190	1118	1111
200	1126	1118
210	1133	1124
220	1140	1132
230	1146	1138
240	1153	1145
250	1159	1151
260	1165	1157
270	1170	1163
280	1176	1167
290	1181	1174
300	1186	1178
301	1187	1179
