## Test report

# Linear joint seals

File           PGA10373a  
Serial No.: 14344  
Ref.:       CAN/TDJ  
Pages:       7  
Encl.:       30

DS/EN 1366-4:2006+A1:2010 Fire resistance tests for service installations- Part 4: Linear joint seals, Annex A Standard condition for linear joint seals with no mechanically induced movement of the joint faces.

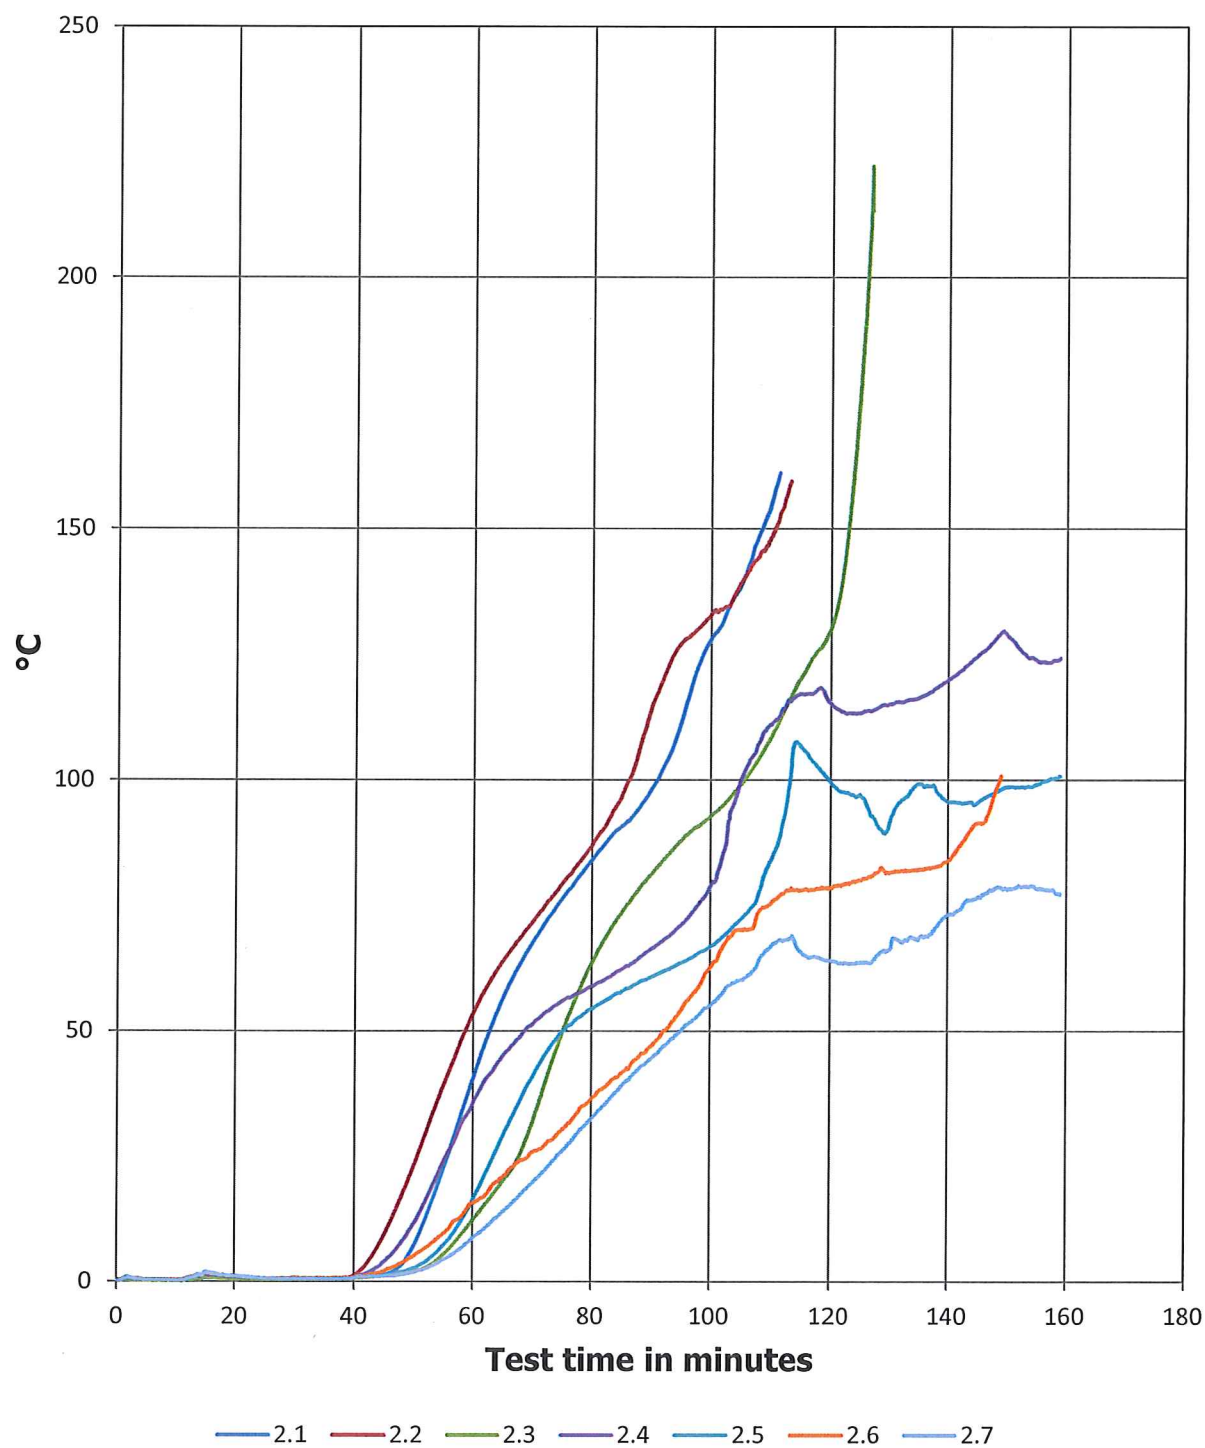
## Temperature rise, test specimen 2

| 96 | 2 | Failure of integrity, due to trough going opening in the top of the sealant. Hole is stopped with ceramic wool. |

| Failure [min] | - | - | 125 | - | - | - | - | 125 |

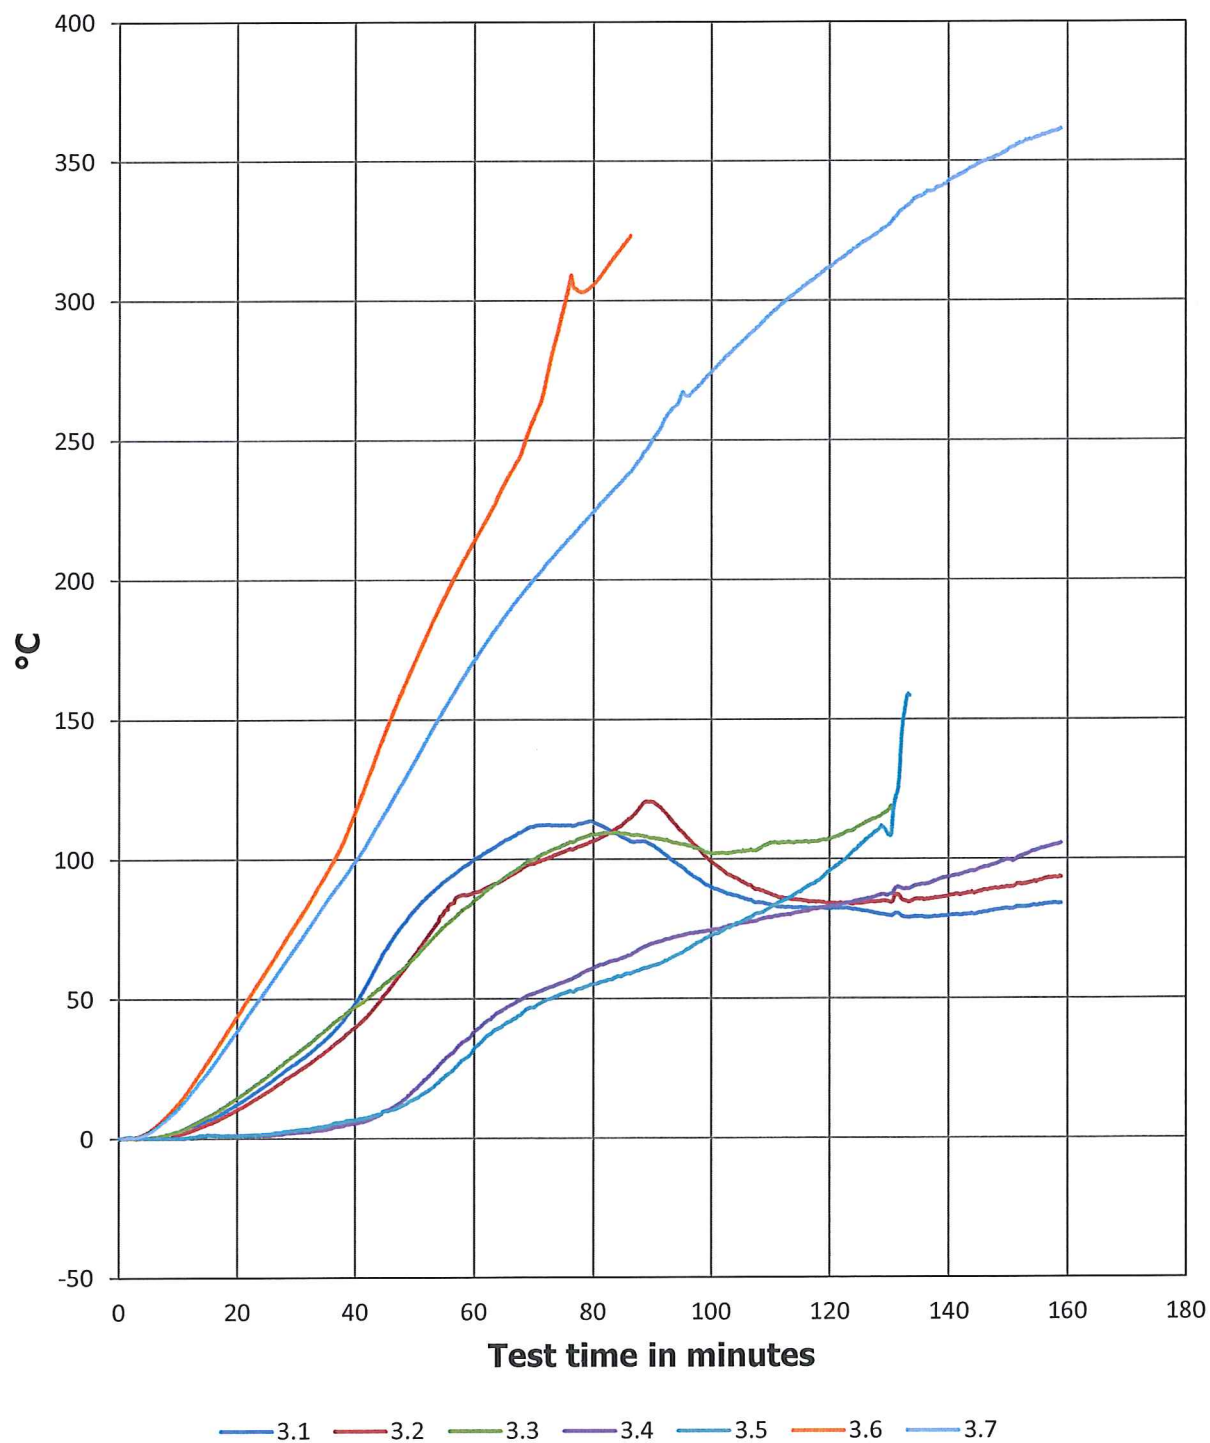
## Temperature rise, test specimen 3

| Time minutes | Test specimen | Observations |
|---|---|---|
| 57 | 3 | Failure of integrity, due to trough going opening in the top of the sealant. |

| Failure [min] | - | - | - | - | - | 51,92 | 62,75 | 51,92 |

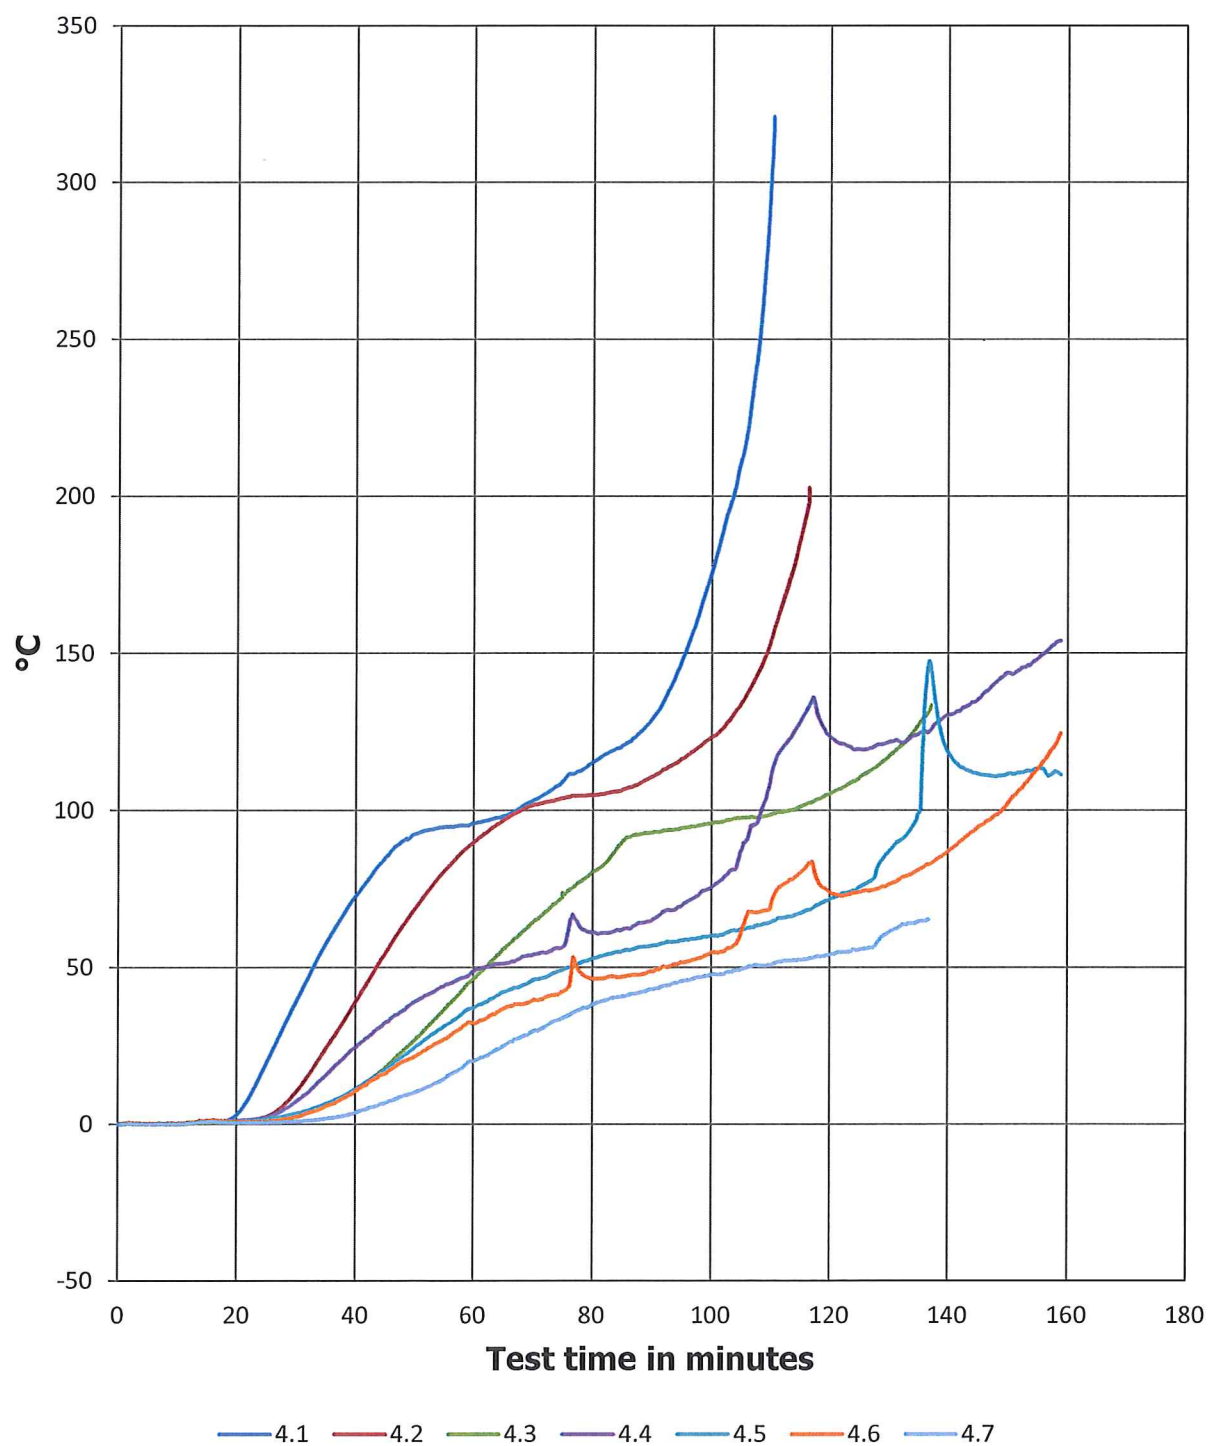
## Temperature rise, test specimen 4

| 90 | 4 | Failure of integrity, due to trough going opening in the top of the sealant. Hole is stopped with ceramic wool. |

| Failure [min] | 100,58 | 114,08 | - | - | - | - | - | 100,58 |

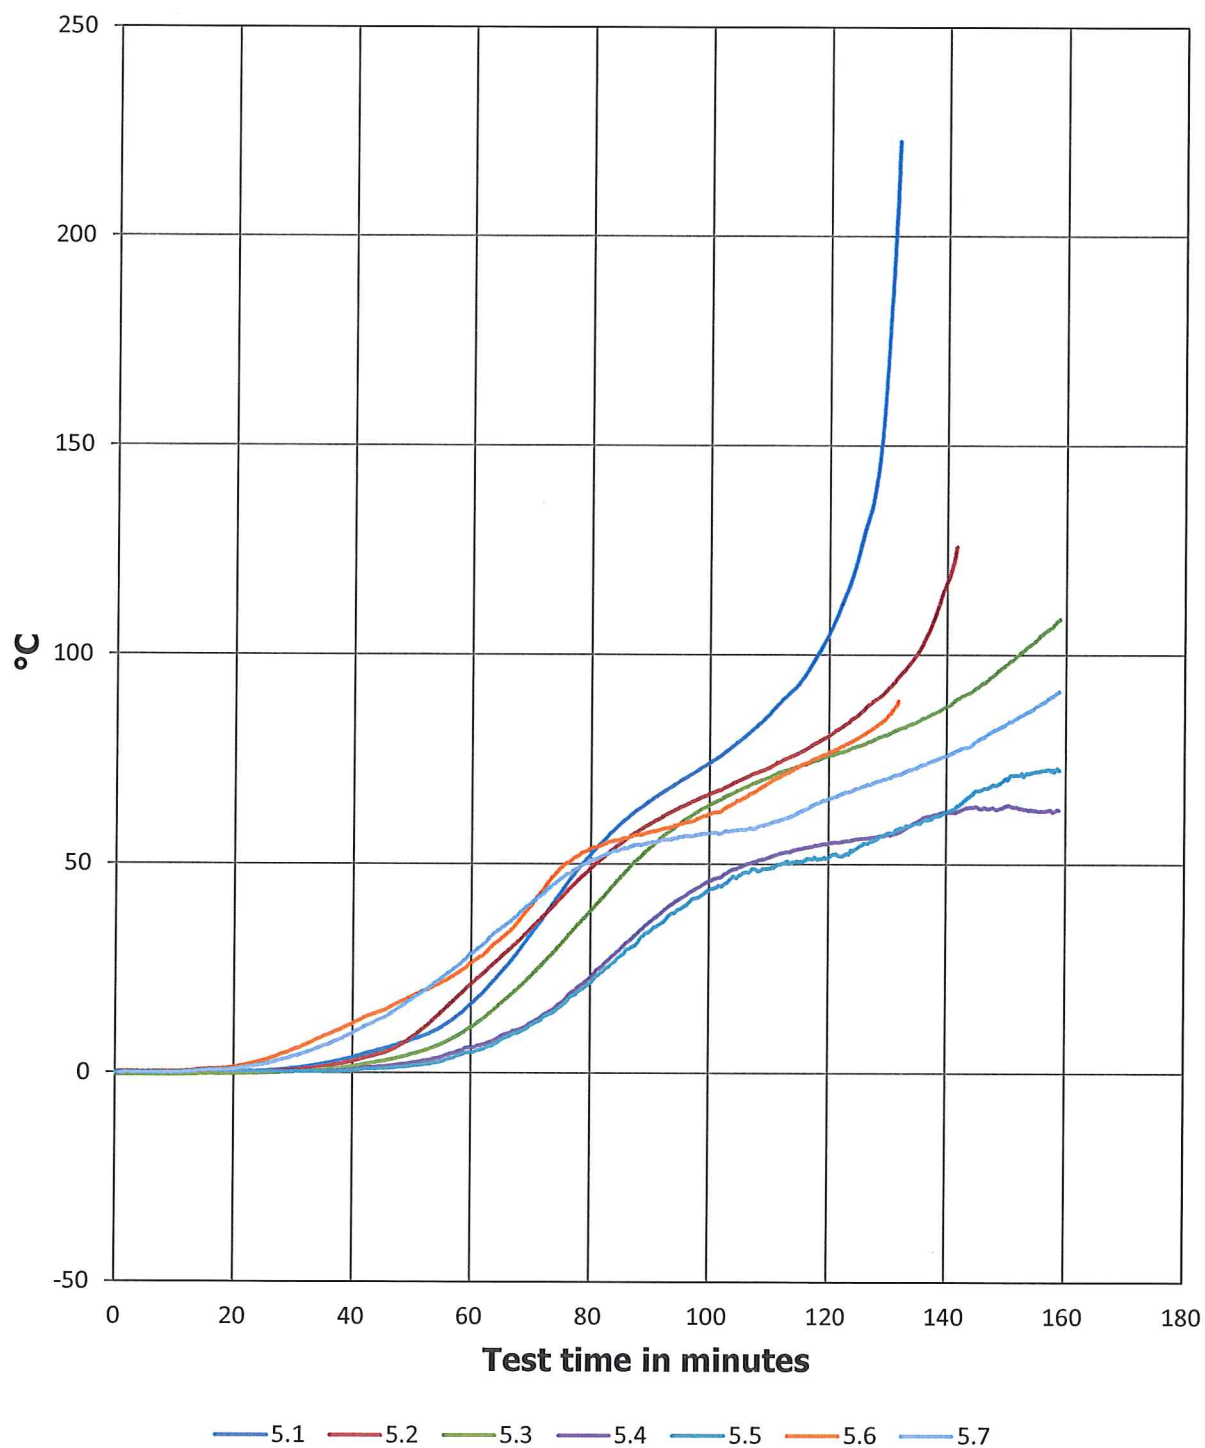
## Temperature rise, test specimen 5

| 123 | 5 | Failure of integrity, due to trough going opening in the top of the sealant. Hole is stopped with ceramic wool. |

| Failure [min] | 130,17 | - | - | - | - | - | - | 130,17 |

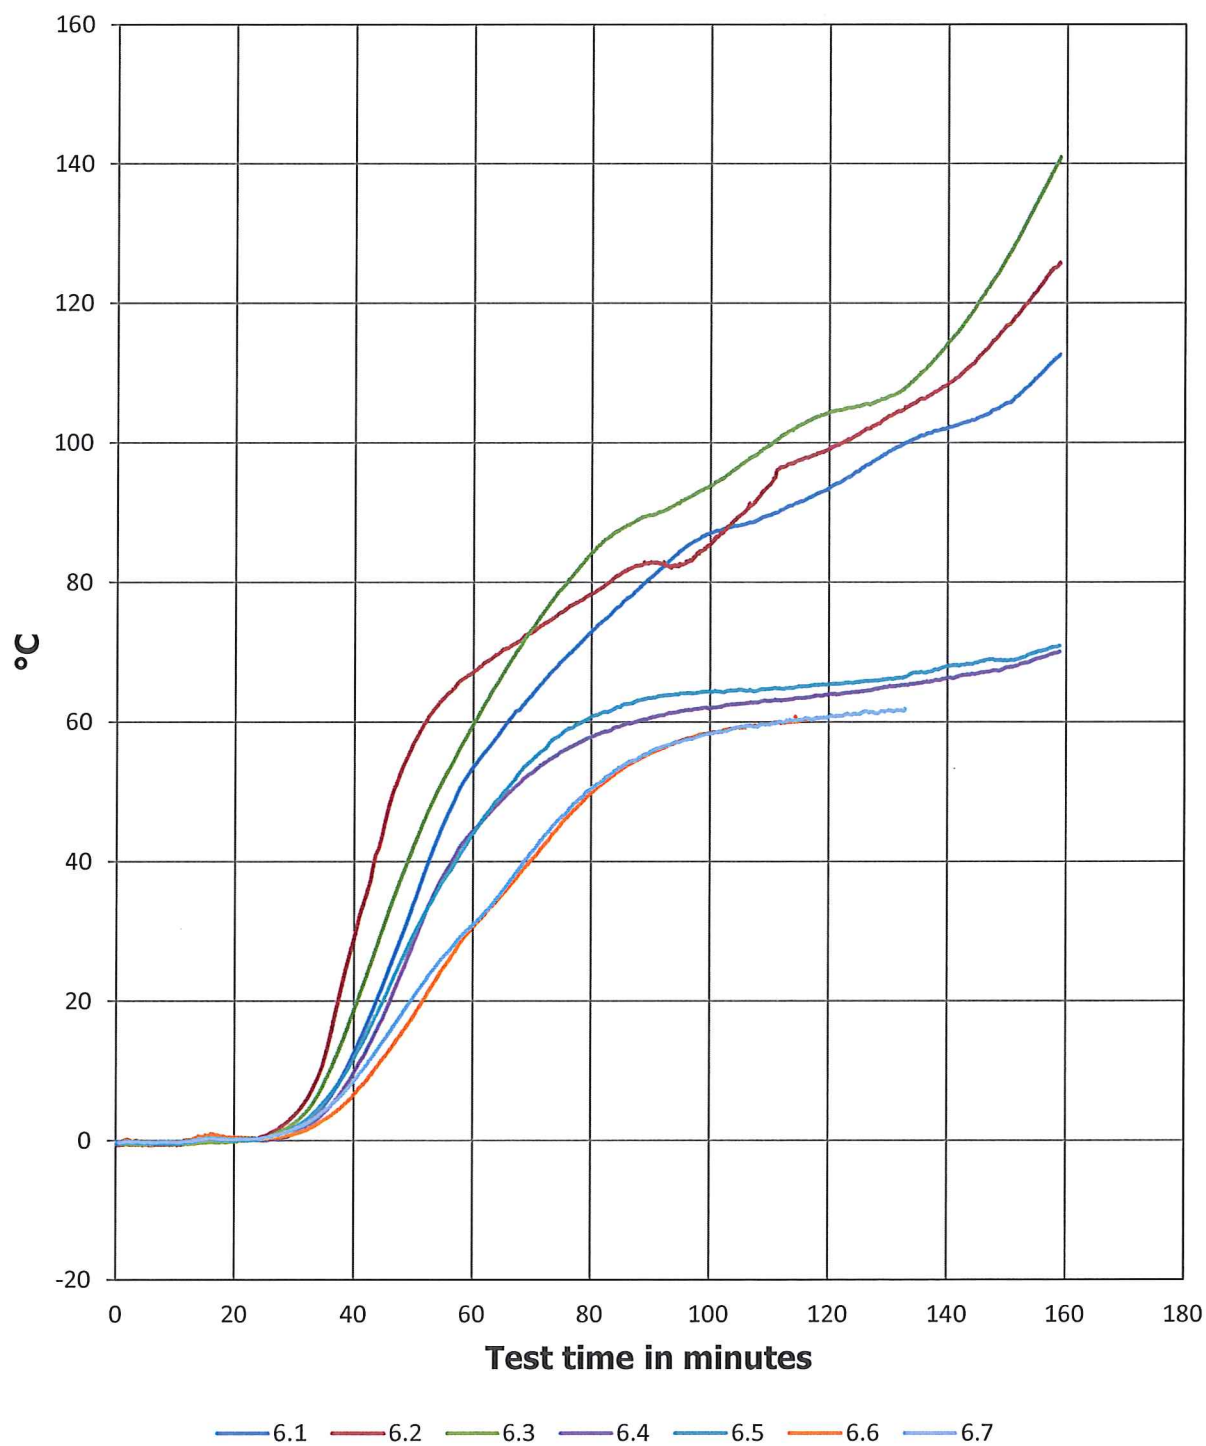
## Temperature rise, test specimen 6

Thermocouple no. 6.6 malfunctioned during the test and thermocouple no. 4.3 loosened slightly during the test. Several thermocouples was removed after integrity failure of the relevant joint seal had occurred.

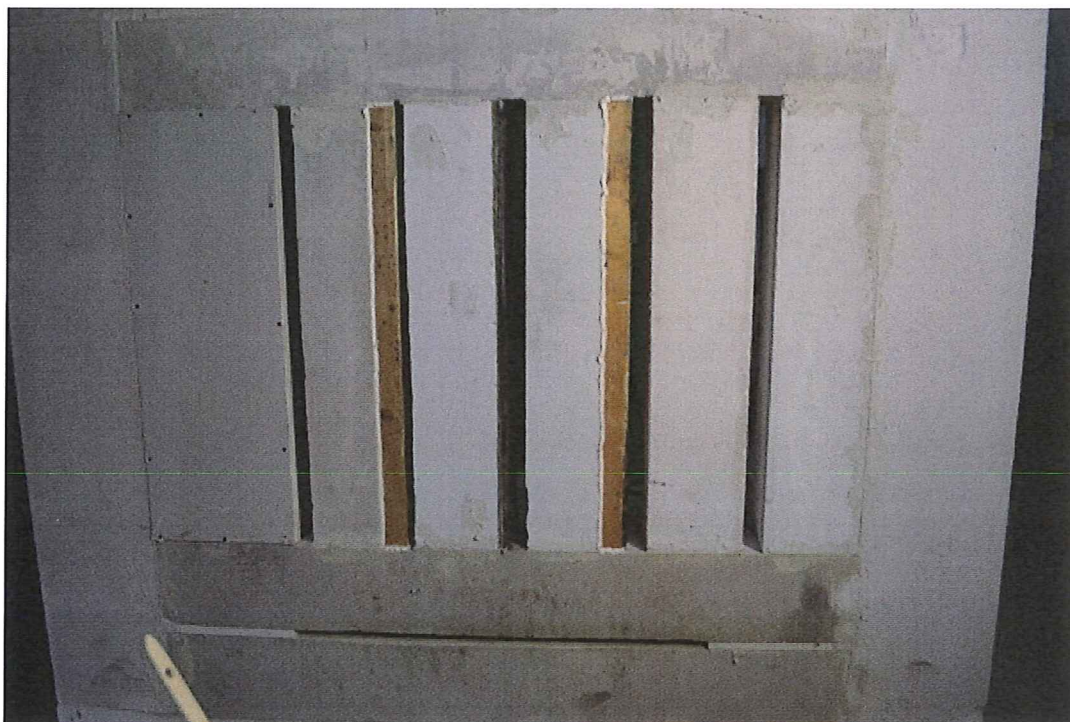
Photo No. 1 Test frame before mounting

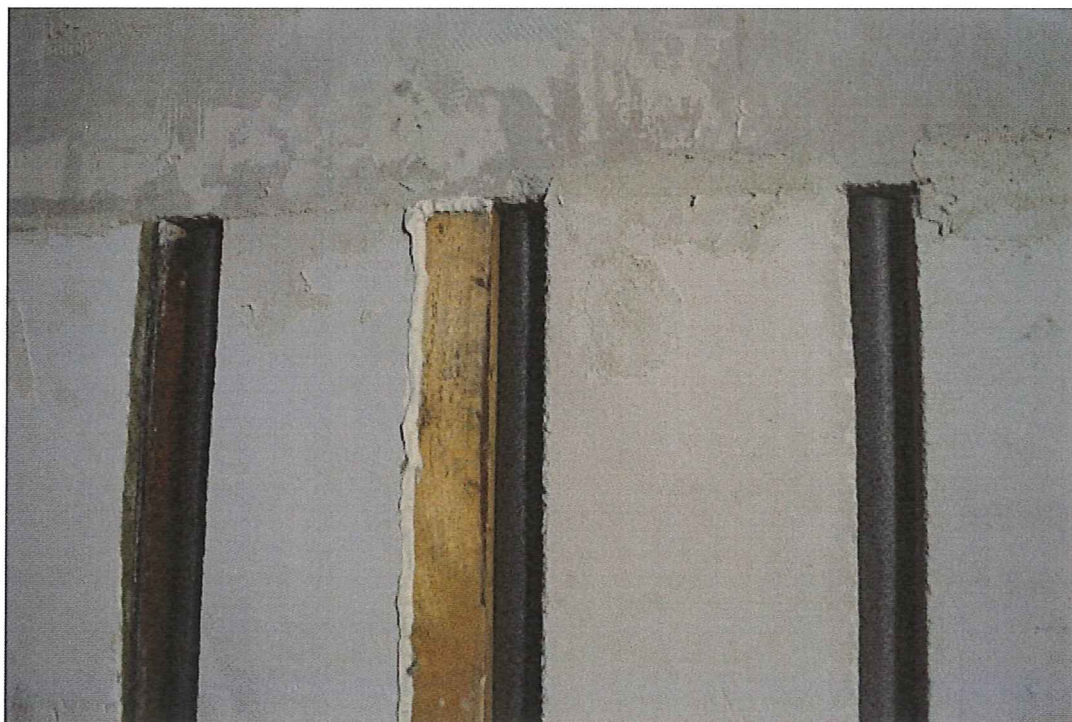
Photo No. 2 Test specimen during mounting

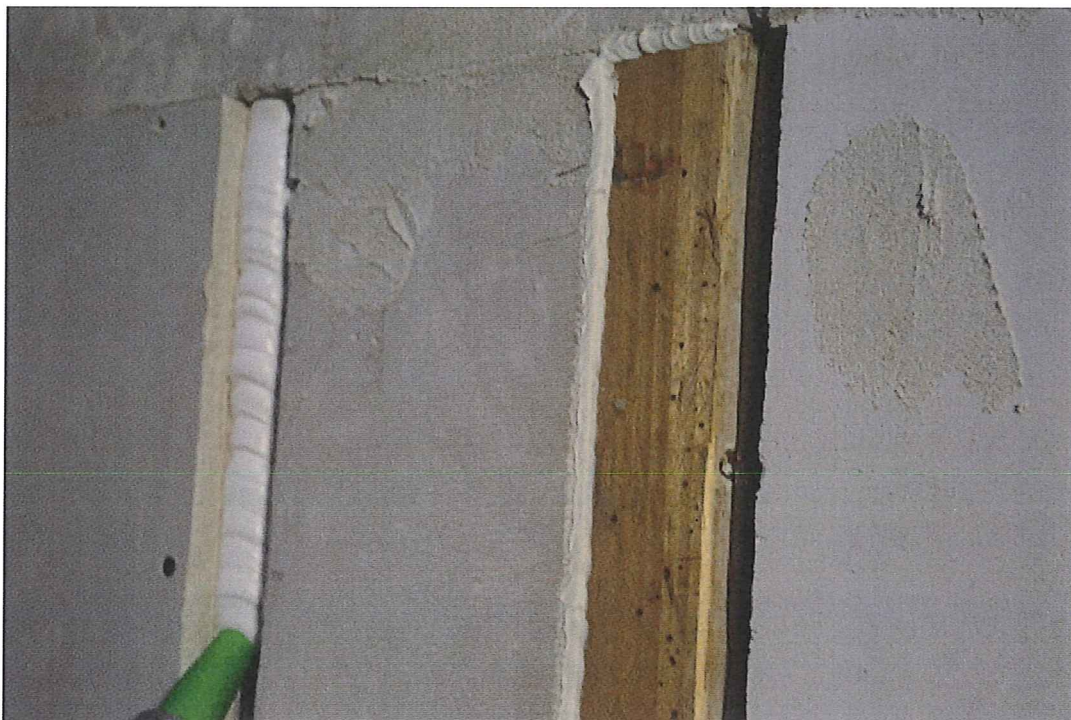
Photo No. 3 Test specimen during mounting

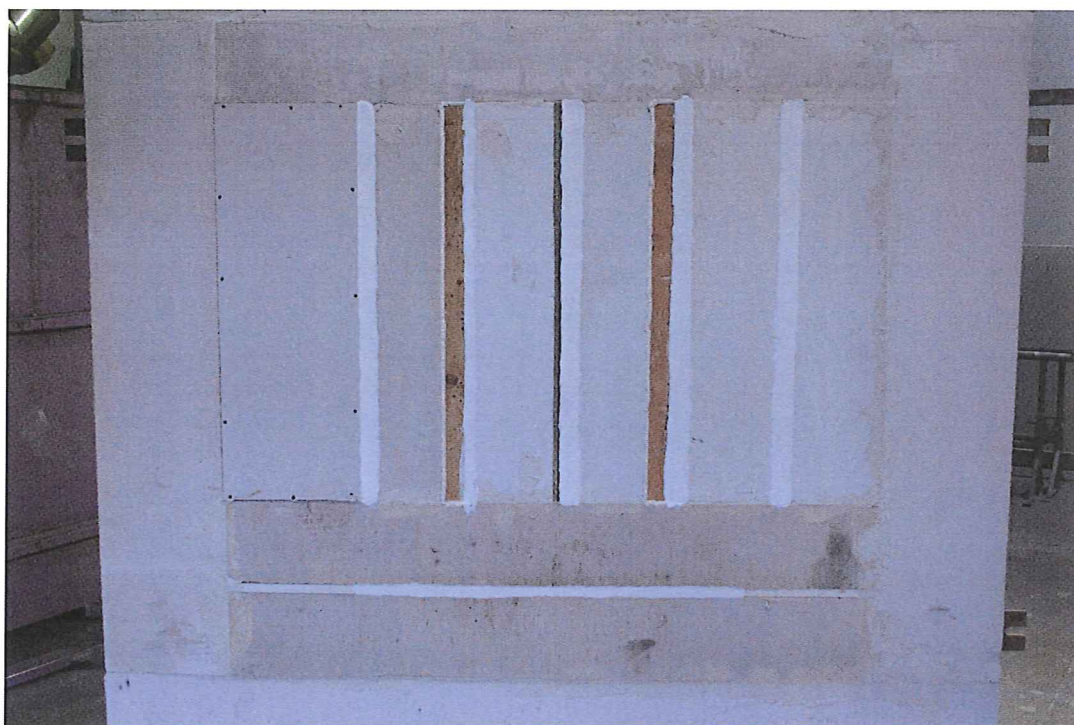
Photo No. 4 Exposed side of test specimen before test

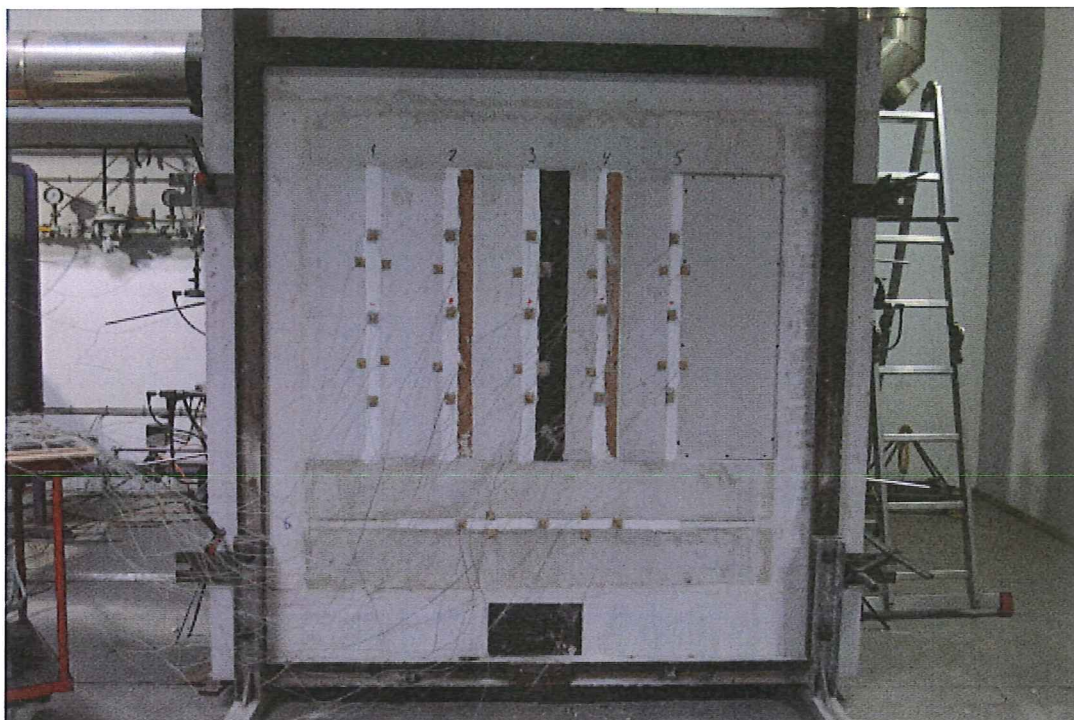
Photo No. 5 Unexposed side of test specimen at test start
